Gilgai and reactive soil geohazards in the City of Melton

Including the Planning Application for a
Place of Worship at 171-197 Harkness Rd,
Harkness

Prepared by: Associate Professor Peter Dahlhaus, Principal Research Fellow

Prepared for: Melton City Council

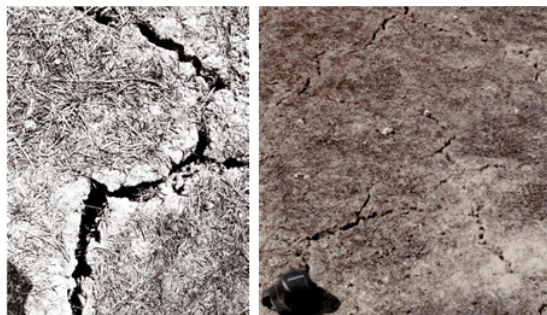
To determine the clay mineral type and properties, the investigation used a combination of soil mechanical tests: liquid limit, plastic limit, Plasticity Index, free swell and linear shrinkage, in combination with soil mineralogy determinations by the State Chemistry Laboratories. The test results showed that the properties of some of the sampled soils were so extreme in their reactivity (i.e. shrink-swell behaviour) that they plotted off the chart in the Australian Standard soil classification and are considered extremely plastic in global terms¹. The most extreme (liquid limit >140, free swell >400%, linear shrinkage $\geq 25\%$) occur around Gloaming Ride, Thrice Lane and Minns Road. Others in the same extreme category are found along Harkness Road, north of the freeway.

Figure 2. Typical shrinkage features
(photos: P. Dahlhaus, 1983, Melton)

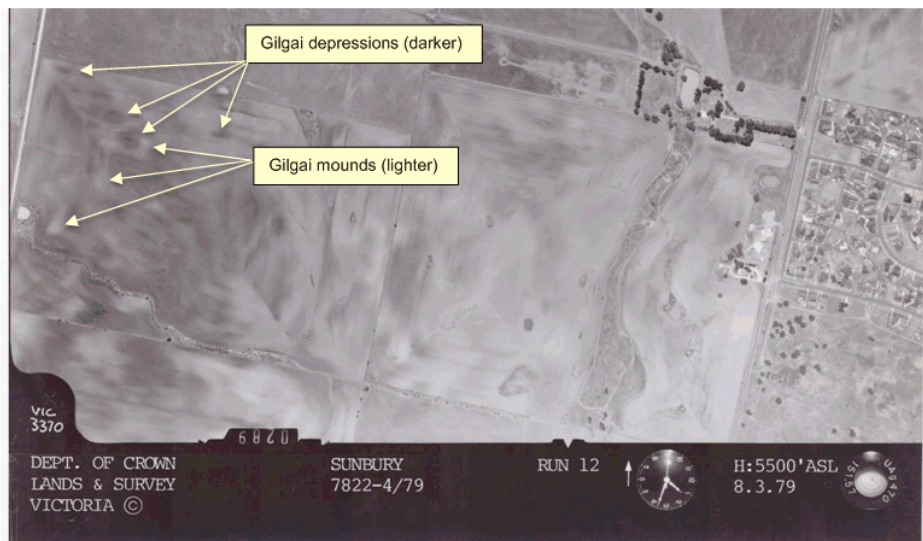
At Melton, the gilgai was recognised in earlier surveys by the Soil Conservation Authority, who mapped large tracts of West Melton and northern Melton as 'gilgaied basalt plain' based on aerial photography and ground observations (SCA, 1978). The gilgai process causes fissuring of the clays, ingestion of fine grained sands deep into the profile, and forms subtle mounds and hollows at the surface. Since the latter 19th century, the micro-relief of hollows and mounds has been subdued by continual ploughing of the land, although the pattern is still recognisable in aerial images (Figure 4). Most of it is now obscured under urban development.

Figure 4. Part of an aerial image of West Melton taken in March 1979 in which the mosaic pattern of the gilgai is clearly visible. Sourced from Dahlhaus (1988 - Plate 18).

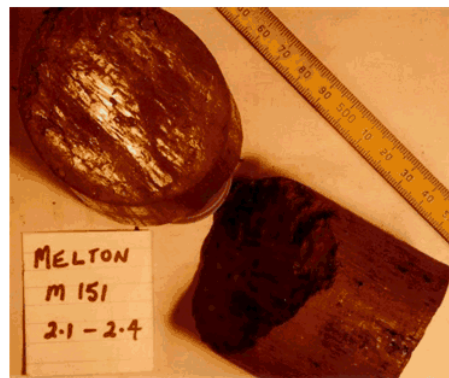
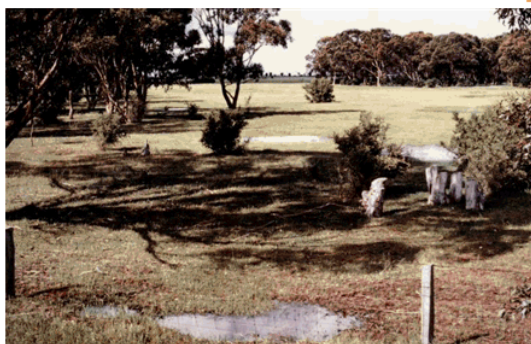
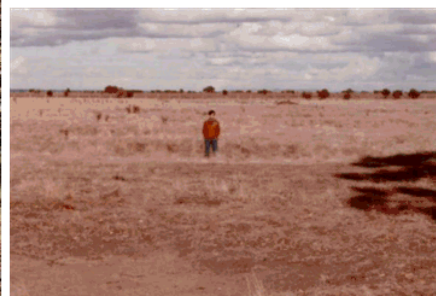
Figure 6. Surface depressions of gilgai features at Harkness, 1984 – 1985.

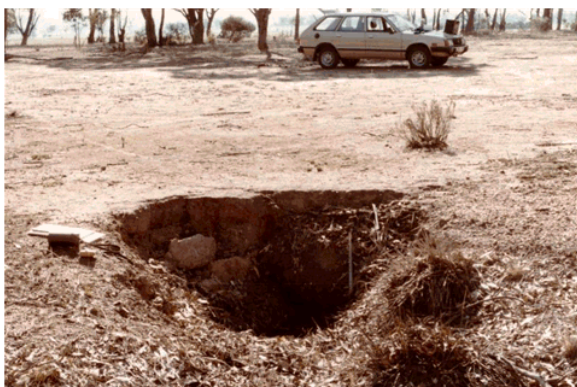
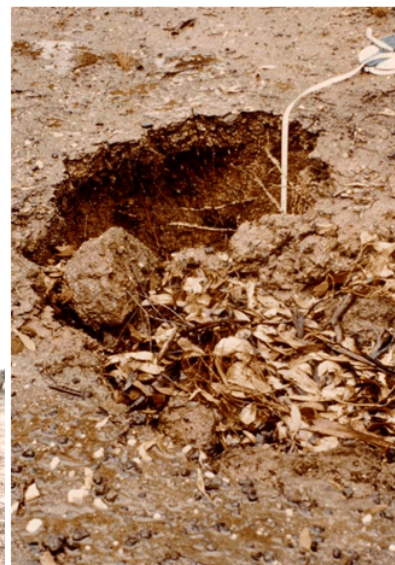
Anecdotal observations recorded in 1984 from the neighbouring resident of 60 years, Mr T Minn, revealed that the subsidence was continuously active, and also occurred on his farm paddocks that were ploughed each year. Active subsidence was observed by the author during the three years of the investigation (Figure 7). The depressions appear to evolve from a small sinkhole into a larger saucer-shaped depression over time.

Figure 7. Recently collapsed soils at Melton (Harkness) in 1985.

(right) in the Harkness Road reserve and (below) in the Melton Gilgai Woodlands nature Conservation Reserve.
Sourced from: Dahlhaus (1986d)

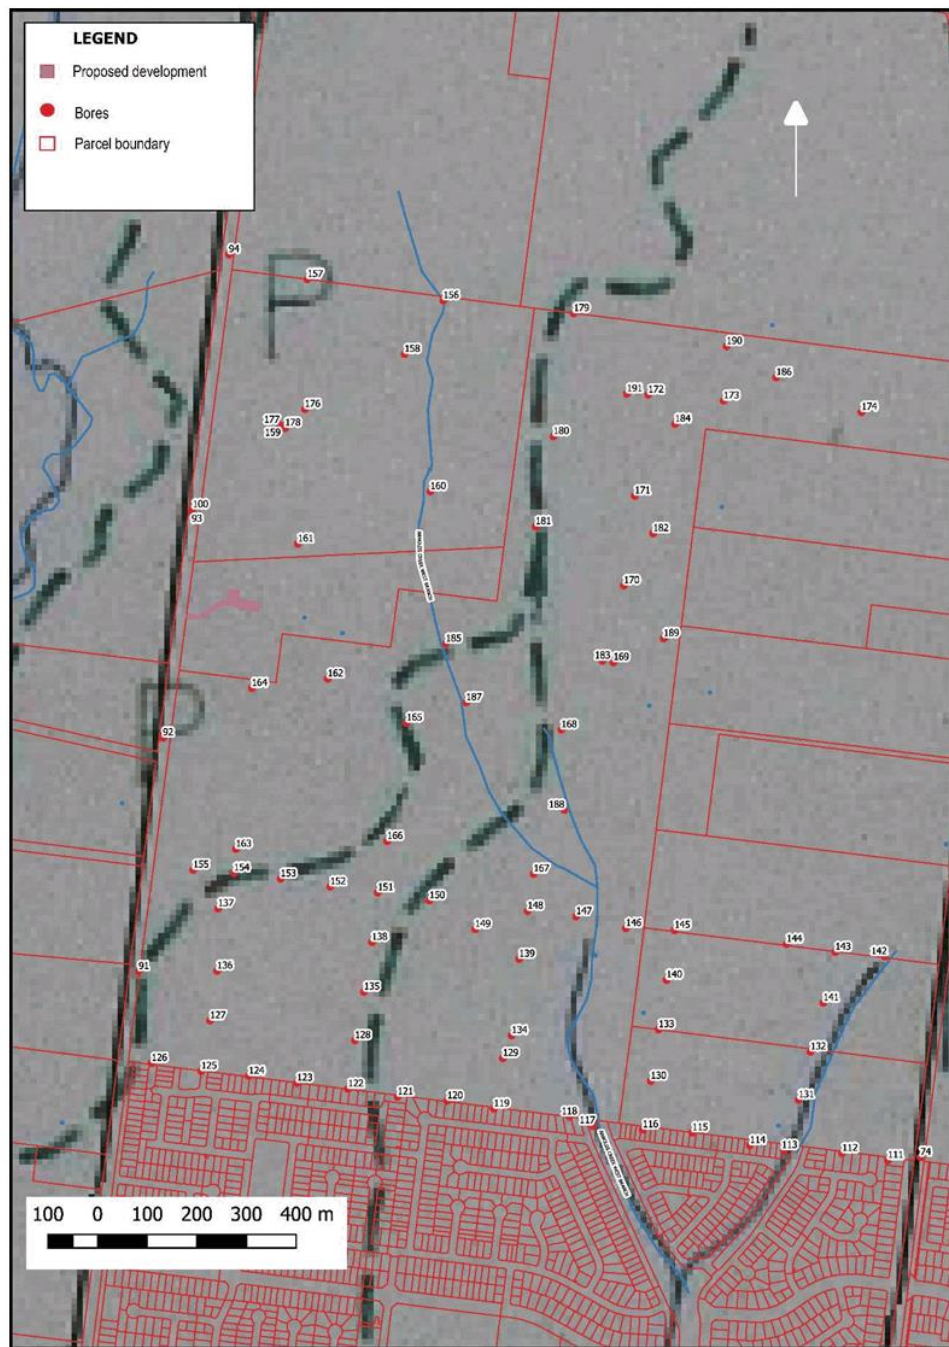
Unsurprisingly, given the limitations and constraints of the ground conditions, the area was classified a Class P (Problem) in AS2970-1986 (Figure 12). The original standard is now superseded by AS2870-2011, which defines:

Hence the Class P remains the current classification given the site conditions.

Figure 12. Proposed site classification for the Harkness area (1986).

The proposed development lies in the polygon designated as Class P (Problem soil).

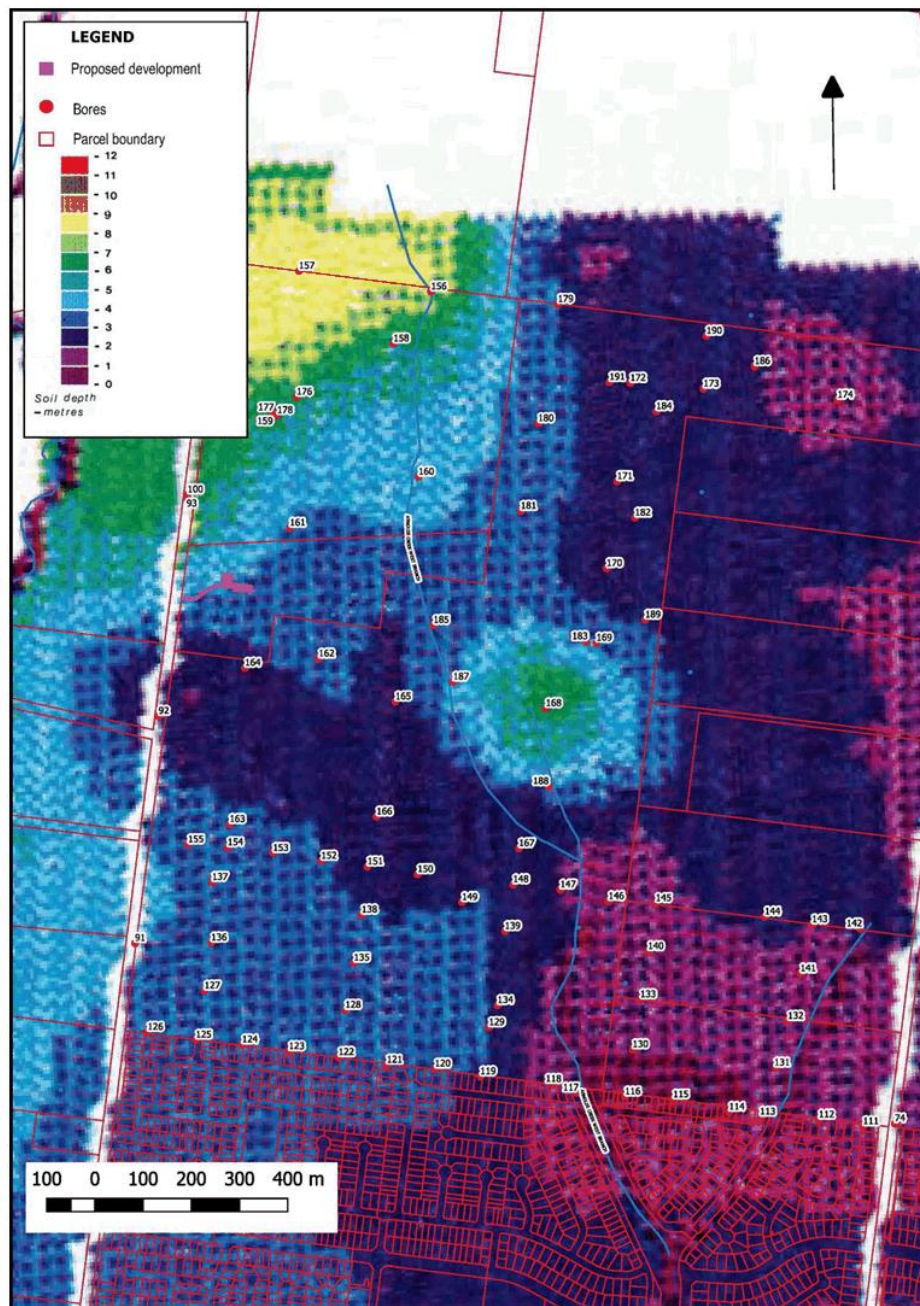
Figure 13. Enlarged view of the modelled soil thickness map (1986), with the bore locations. The proposed development is underlain by soils modelled as around four metres thick.

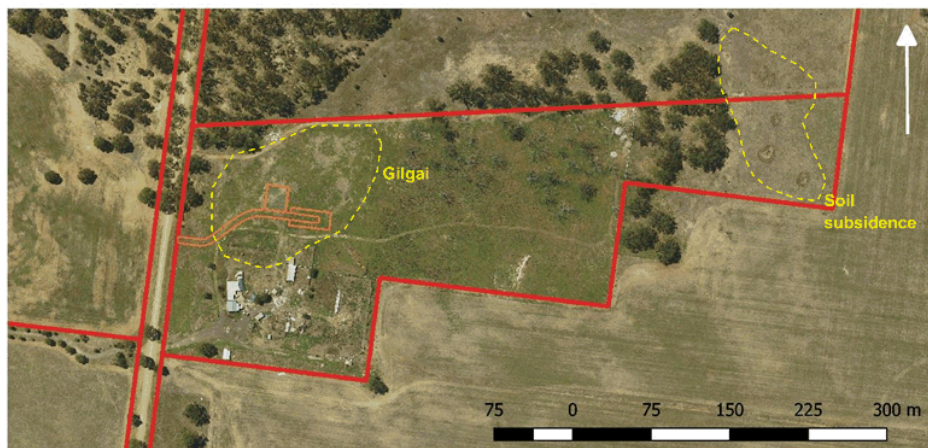
Figure 14. Some of the more obvious geohazards at the proposed development site as seen in aerial imagery. (source Melton City Council. Imagery captured January 16, 2018)

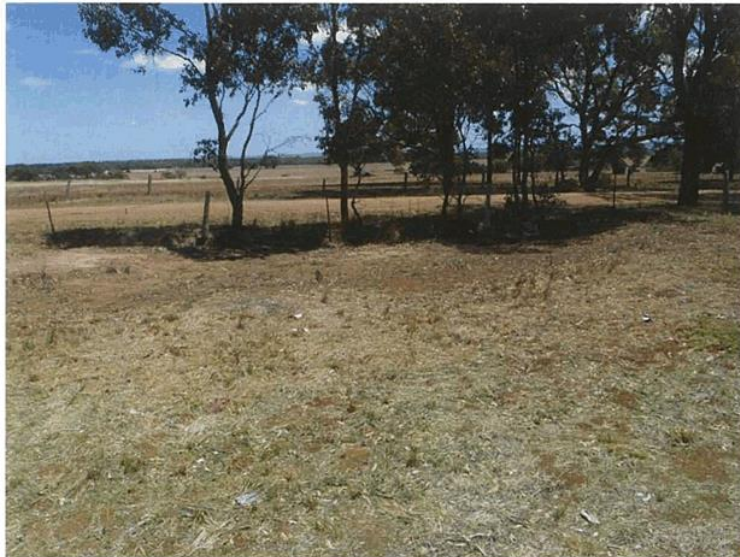
Figure 1: Depressions on western side of Site indicative of gilgai, view west towards Harkness Road

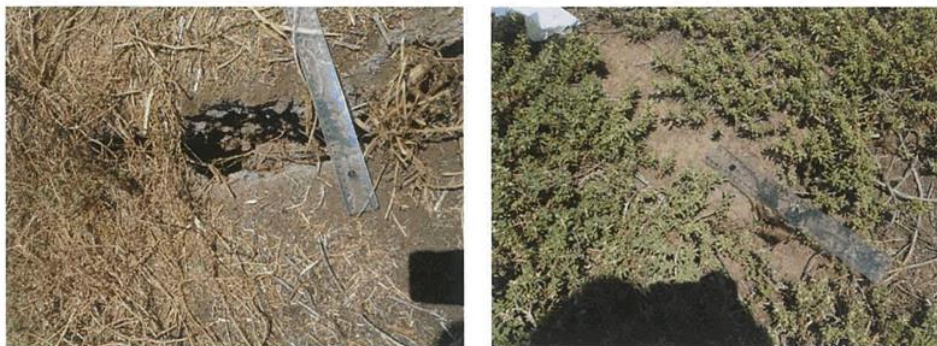
- 24) Shrinkage cracks are evident on the ground surface over most of the Site. In the extreme case, the cracks have apertures greater than 100 mm (Figure 2).

Figure 2: Examples of shrinkage cracks, some of which have apertures greater than 100 mm

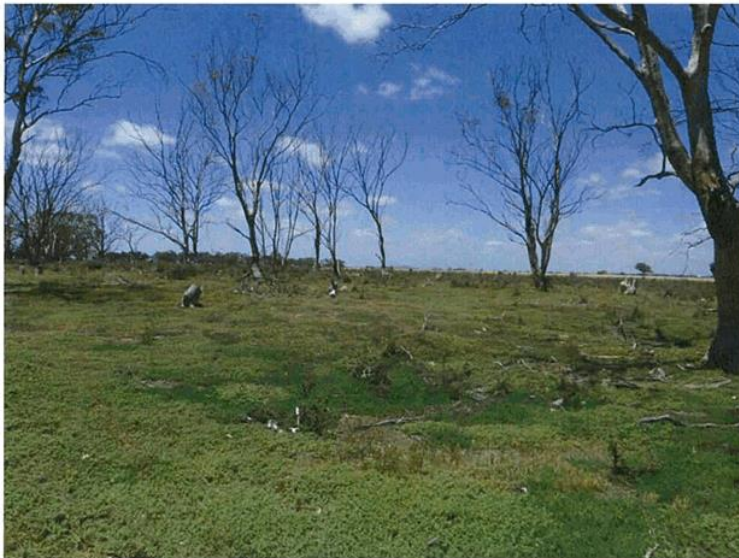
- 25) The intensity of gilgai features and surface cracking appears to be greater in the vicinity of trees. There are extensive gilgais and evidence of ground cracking on the eastern side of the Site in the vicinity of sparse vegetation (Figure 3).

Figure 3: Depressions indicative of Gilgai formation near vegetation, eastern side of the Site, view to east

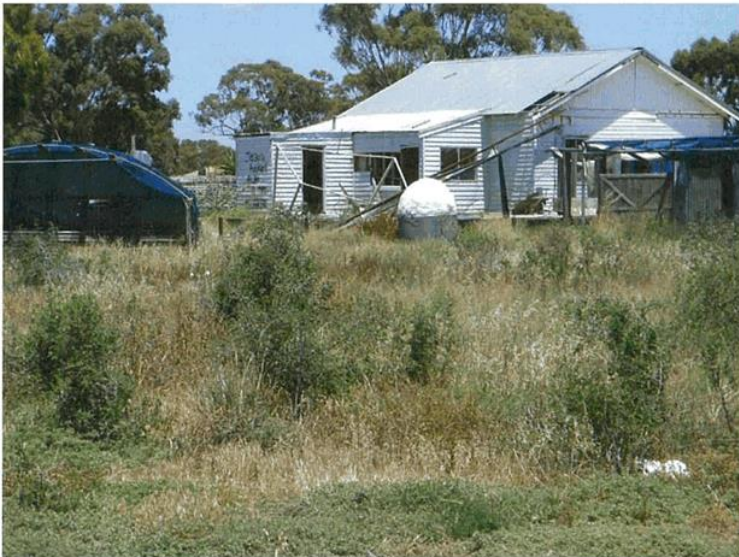
- 26) There are existing buildings towards the southern side of the Site, comprised of sheds and a timber framed, weatherboard house (Figure 4). The weatherboard house shows some evidence of ground movement, however generally appears to be intact.

Figure 4: Dilapidated weatherboard house, view towards south

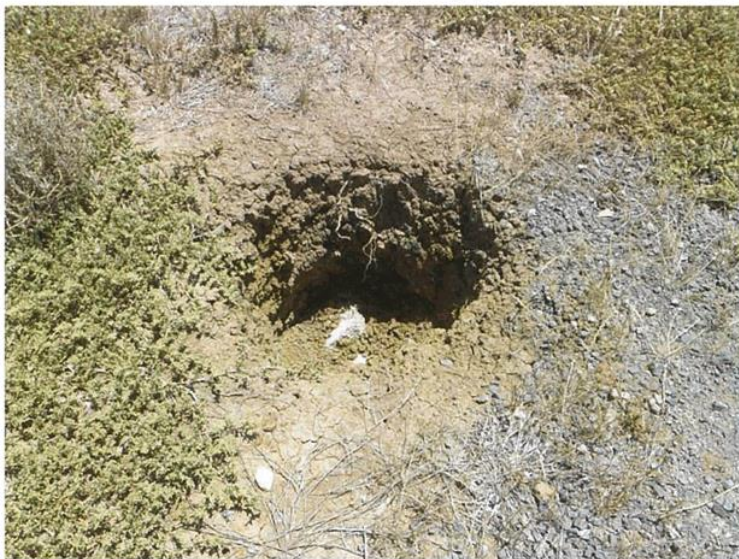
- 27) Based on a an observation of a series of holes of about 300 mm diameter, there appears to have been some recent excavation at the approximate location of the proposed mosque (Figure 5). Fill assumed to have been removed from the excavation appears to have been placed adjacent to these holes.

Figure 5: Circular excavation near location of proposed mosque

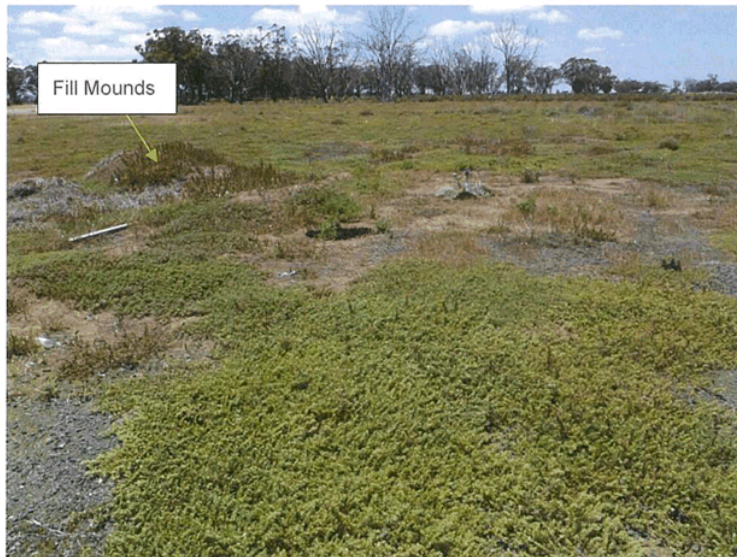
- 28) There are subtle gilgai features at the location of the proposed mosque (Figure 6). However, these features are not as pronounced as they are on other parts of the Site.

Figure 6: Approximate location of proposed mosque, view to east.
