Gilgai and reactive soil geohazards in the City of Melton

Including the Planning Application for a
Place of Worship at 171-197 Harkness Rd,
Harkness

Prepared by: Associate Professor Peter Dahlhaus, Principal Research Fellow
Prepared for: Melton City Council

Date: 31/08/2018

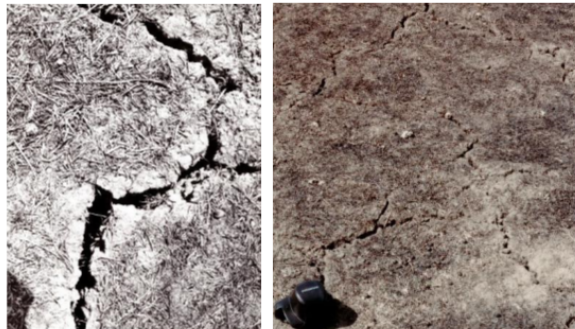
Figure 2. Typical shrinkage features
(photos: P. Dahlhaus, 1983, Melton)

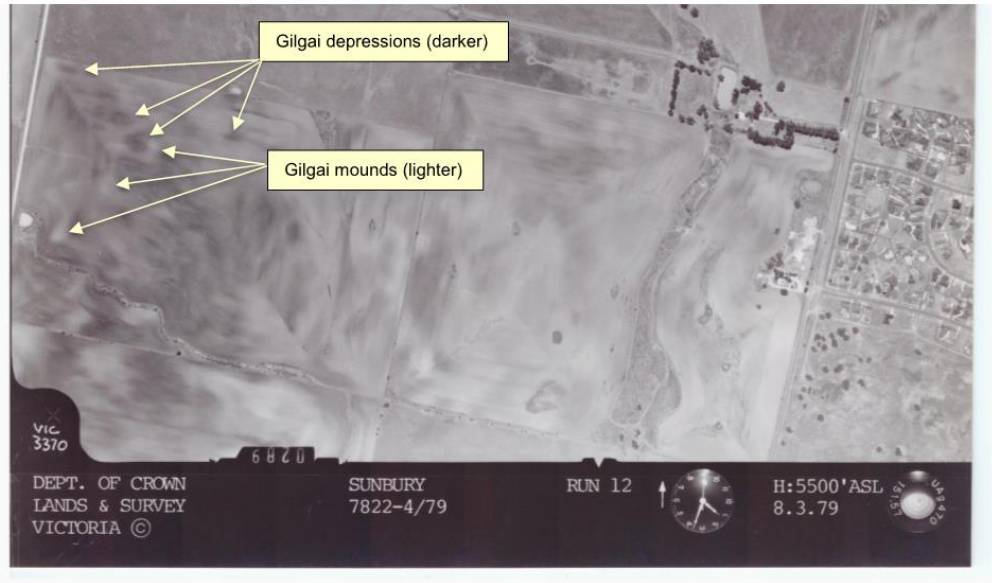
At Melton, the gilgai was recognised in earlier surveys by the Soil Conservation Authority, who mapped large tracts of West Melton and northern Melton as 'gilgaied basalt plain' based on aerial photography and ground observations (SCA, 1978). The gilgai process causes fissuring of the clays, ingestion of fine grained sands deep into the profile, and forms subtle mounds and hollows at the surface. Since the latter 19th century, the micro-relief of hollows and mounds has been subdued by continual ploughing of the land, although the pattern is still recognisable in aerial images (Figure 4). Most of it is now obscured under urban development.

Figure 4. Part of an aerial image of West Melton taken in March 1979 in which the mosaic pattern of the gilgai is clearly visible. Sourced from Dahlhaus (1988 - Plate 18).

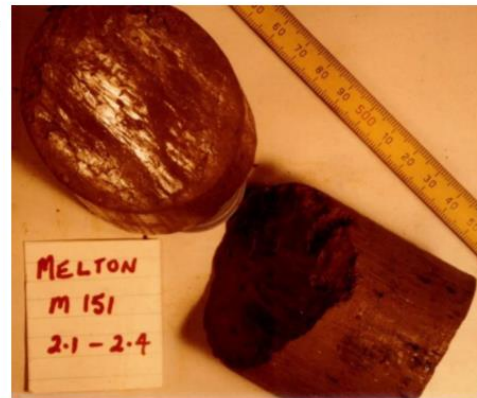
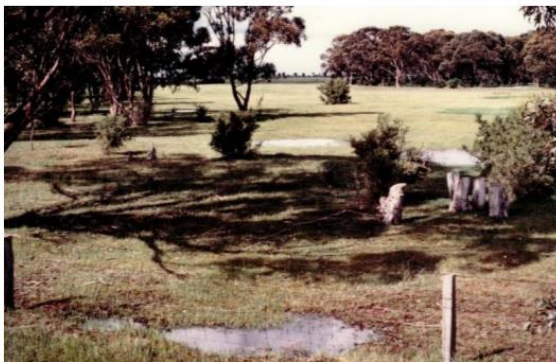
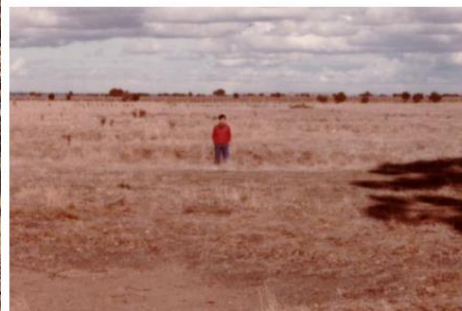
Figure 5. Polished shear surface, or slickenside, in a clay core sample from Melton
Sourced from: (Dahlhaus, 1986d; 1988)

Figure 6. Surface depressions of gilgai features at Harkness, 1984 – 1985.
Source: Dahlhaus (1985)

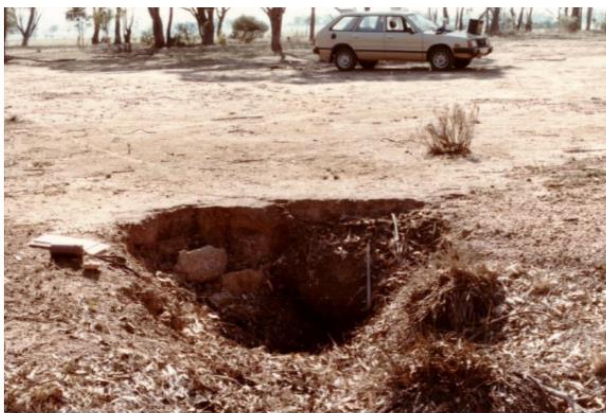
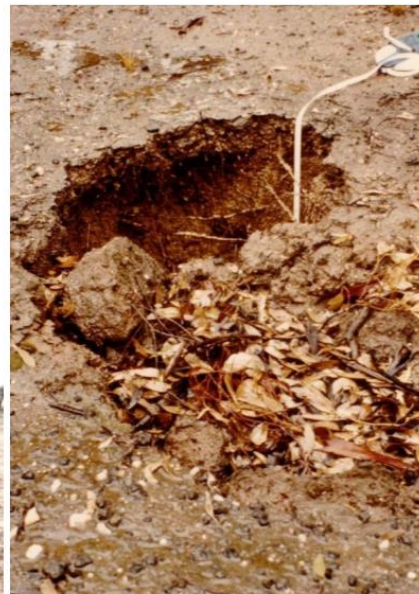
Anecdotal observations recorded in 1984 from the neighbouring resident of 60 years, Mr T Minn, revealed that the subsidence was continuously active, and also occurred on his farm paddocks that were ploughed each year. Active subsidence was observed by the author during the three years of the investigation (Figure 7). The depressions appear to evolve from a small sinkhole into a larger saucer-shaped depression over time.

(right) in the Harkness Road reserve and
(below) in the Melton Gilgai Woodlands nature
Conservation Reserve.

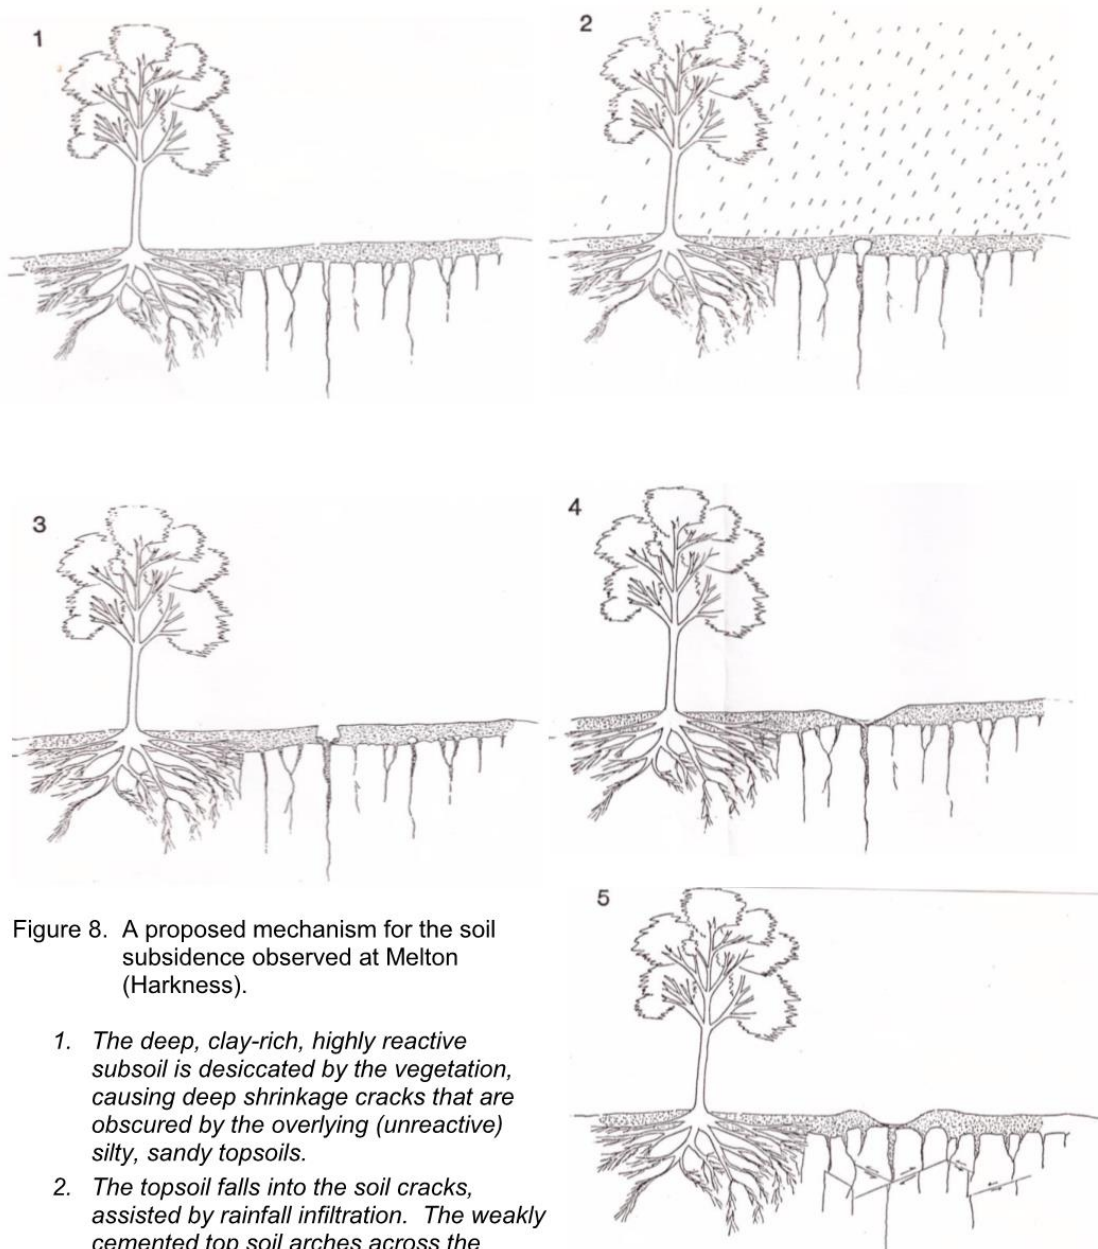
In this area a relatively thin layer of sand and gravel overlies thick clay-rich subsoils and this profile provides a proposed mechanism for the subsidence (Figure 8). The conceptualisation fits with most observed features, especially the numerous fissures seen in all soil cores extracted from all bores drilled at the site. Fissuring was logged through the full depth of the profile - over nine metres in places - many fissures filled with sand with tree rootlets along the fissures, and many with polished surfaces (termed slickensides) caused by movement (shear failure of the soil).

Figure 8. A proposed mechanism for the soil subsidence observed at Melton (Harkness).

1. *The deep, clay-rich, highly reactive subsoil is desiccated by the vegetation, causing deep shrinkage cracks that are obscured by the overlying (unreactive) silty, sandy topsoils.*
2. *The topsoil falls into the soil cracks, assisted by rainfall infiltration. The weakly cemented top soil arches across the subsoil crack, creating a void.*
3. *The topsoil collapses forming a 'sinkhole'.*
4. *The sides of the sinkhole are eroded into a saucer-shaped depression.*
5. *The subsequent swelling of the subsoil creates shear stresses, slickensides and fissures to buckle the surface into typical gilgai relief.*

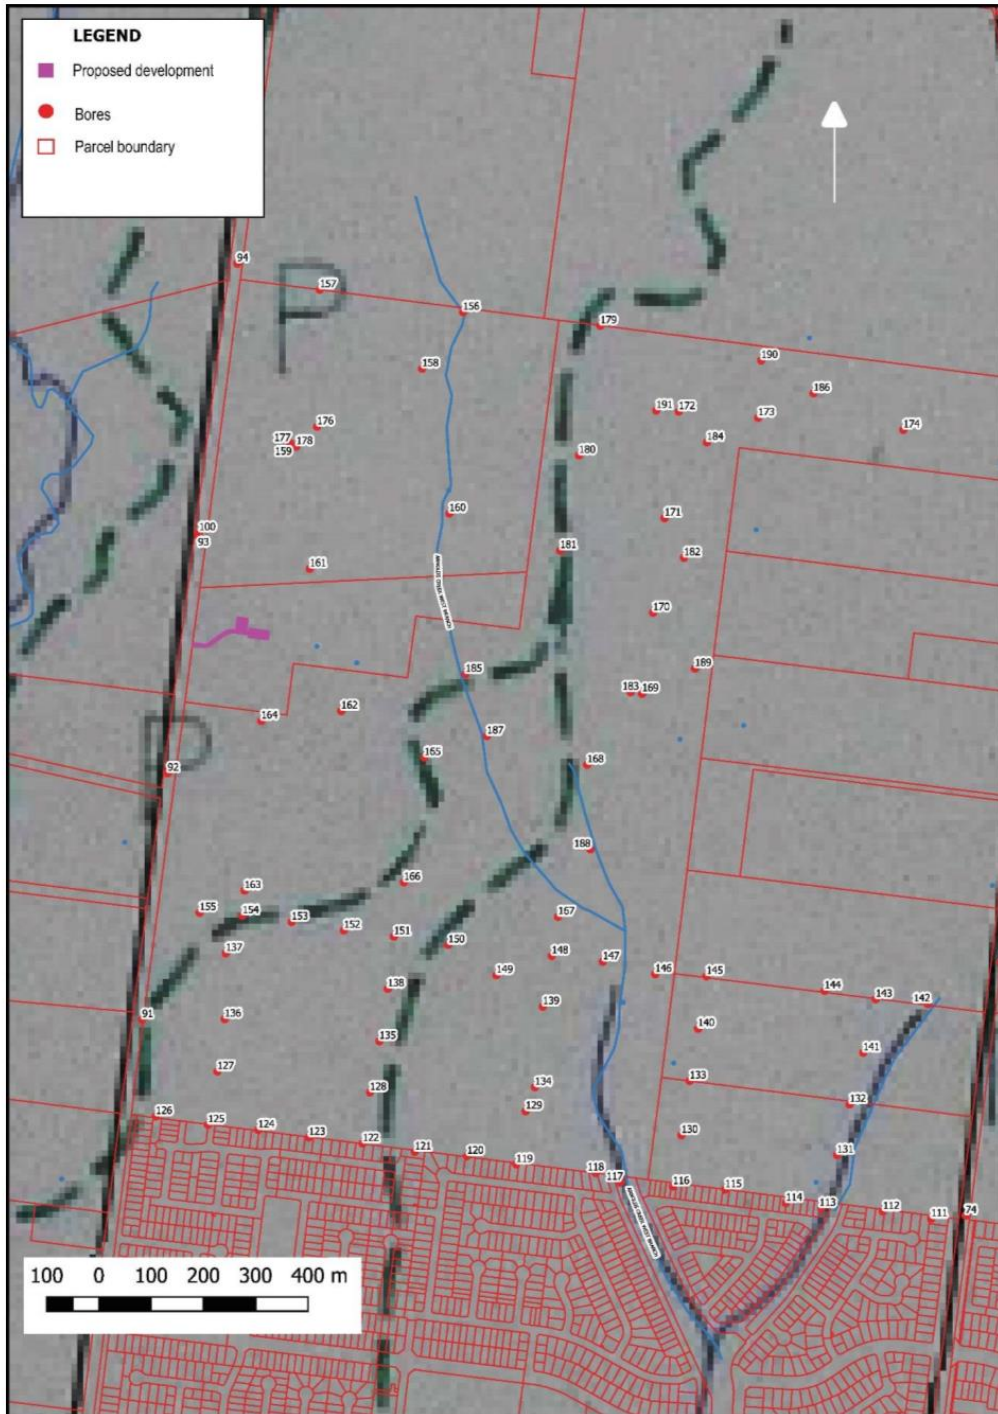
Unsurprisingly, given the limitations and constraints of the ground conditions, the area was classified a Class P (Problem) in AS2970-1986 (Figure 12). The original standard is now superseded by AS2870-2011, which defines:

Hence the Class P remains the current classification given the site conditions.

Figure 12. Proposed site classification for the Harkness area (1986).

The proposed development lies in the polygon designated as Class P (Problem soil).

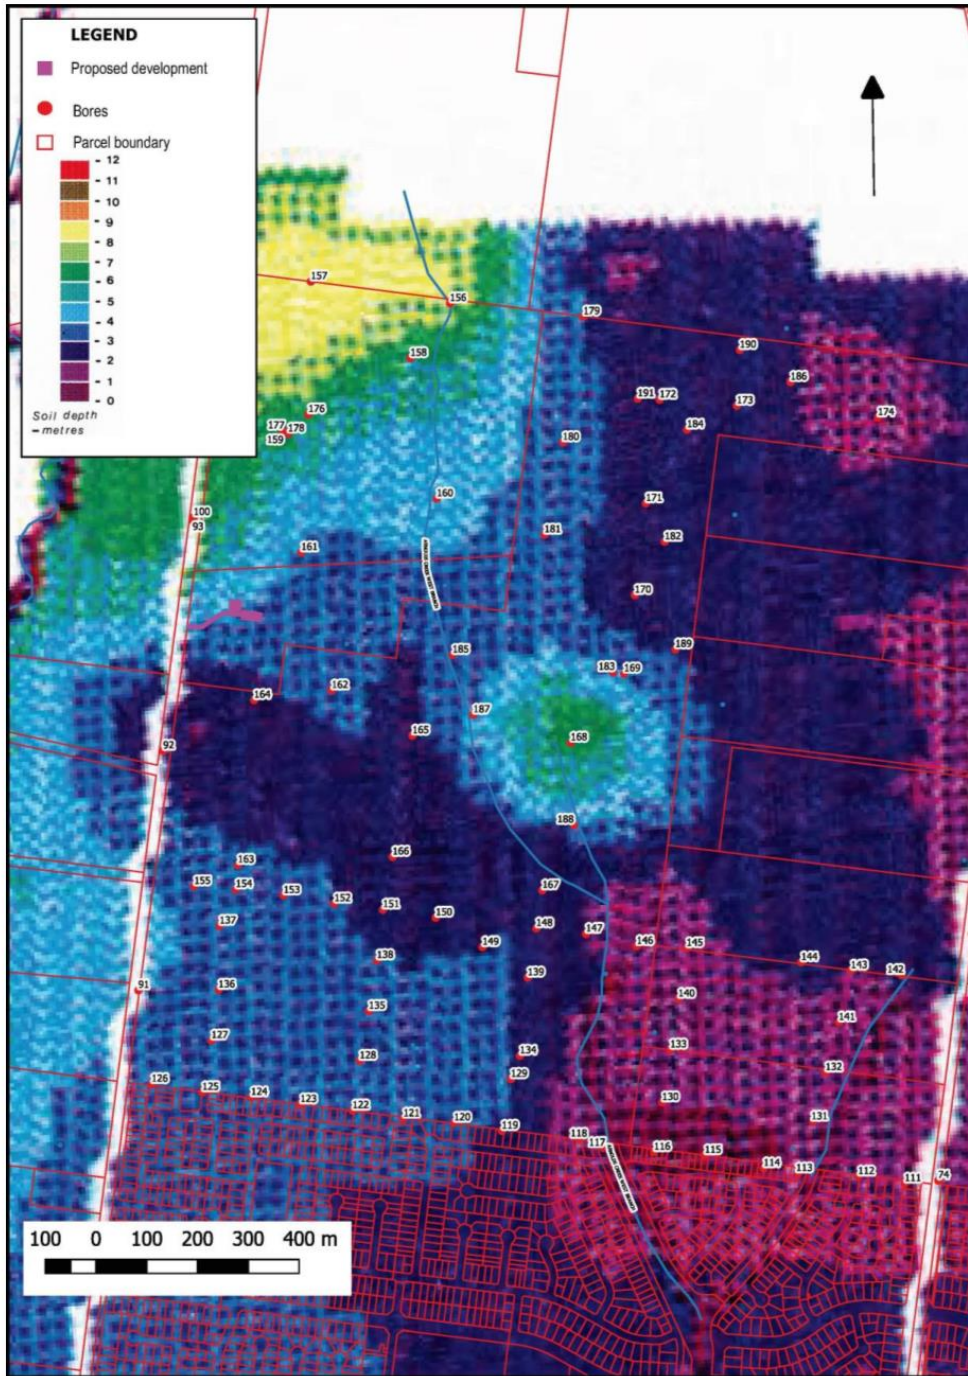
Figure 13. Enlarged view of the modelled soil thickness map (1986), with the bore locations. The proposed development is underlain by soils modelled as around four metres thick.

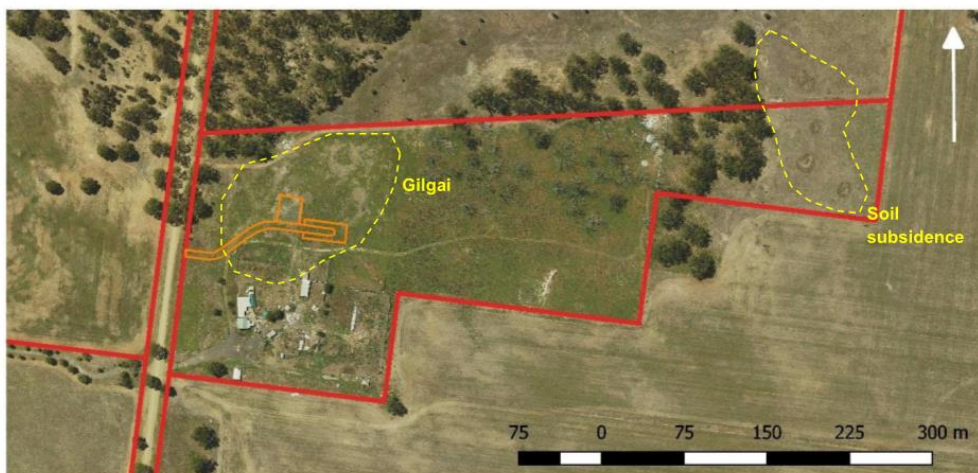
Figure 14. Some of the more obvious geohazards at the proposed development site as seen in aerial imagery. (source Melton City Council. Imagery captured January 16, 2018)

The soil collapse features are obvious on the east of the Applicant's site (Figure 14) and subtle gilgai depressions are noted on the western side, confirming² that the likelihood of geohazards at the site is Certain (Table 2). The consequence of the geohazards will depend entirely on the engineered solution. This would require a detailed geotechnical investigation to inform the potential engineered solutions and landscape design elements. The most challenging of these is the enduring management of soil moisture, which is the trigger for the geohazard processes. Hence, the wastewater disposal, runoff and storm water management, vegetation species selection and siting, garden irrigation, and the extents of the impervious surfaces are the most critical design considerations. However, even if the development could be engineered and designed to reduce the consequences of the geohazards to Moderate or Minor (Table 3), the risk remains High to Moderate (Table 4).

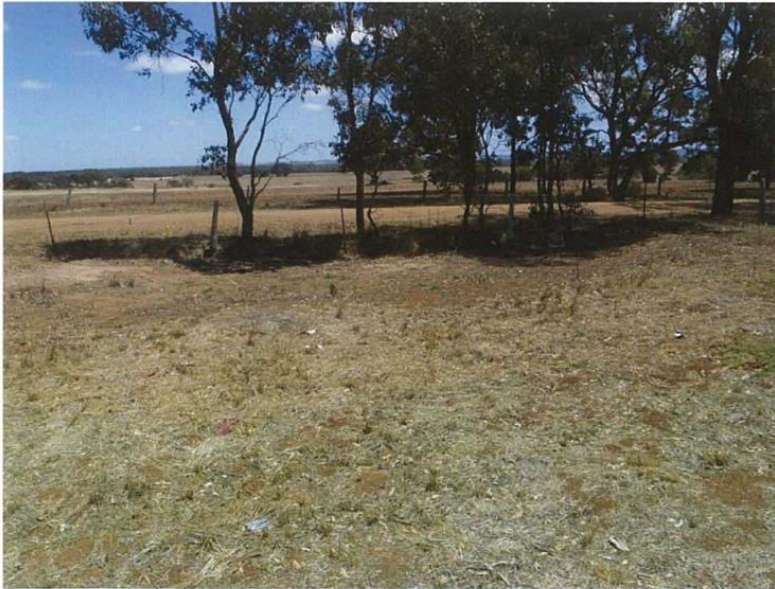
Figure 1: Depressions on western side of Site indicative of gilgai, view west towards Harkness Road

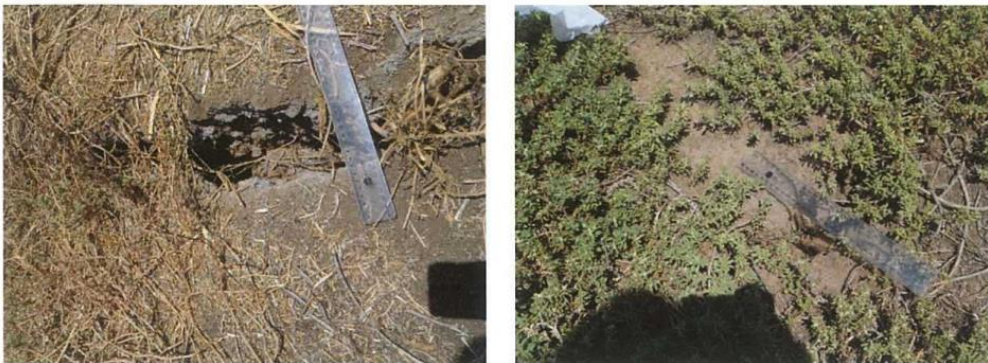
- 24) Shrinkage cracks are evident on the ground surface over most of the Site. In the extreme case, the cracks have apertures greater than 100 mm (Figure 2).

Figure 2: Examples of shrinkage cracks, some of which have apertures greater than 100 mm

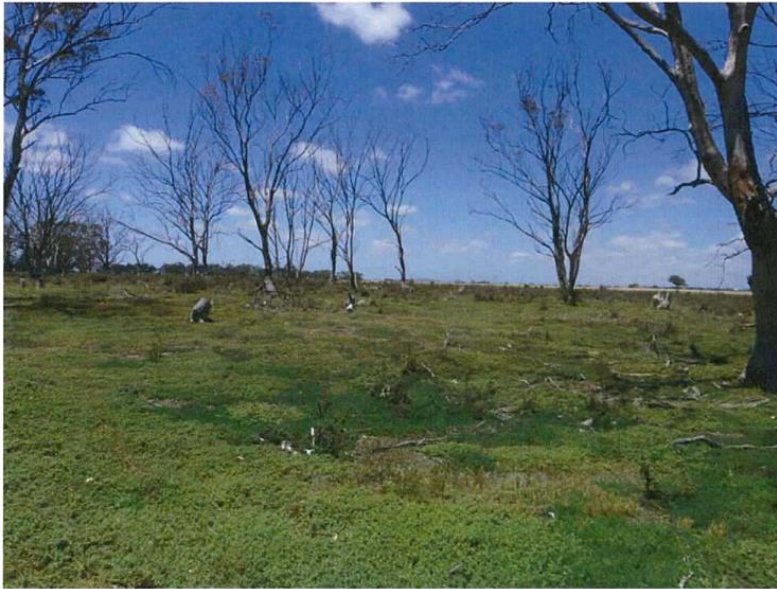
- 25) The intensity of gilgai features and surface cracking appears to be greater in the vicinity of trees. There are extensive gilgais and evidence of ground cracking on the eastern side of the Site in the vicinity of sparse vegetation (Figure 3).

Figure 3: Depressions indicative of Gilgai formation near vegetation, eastern side of the Site, view to east

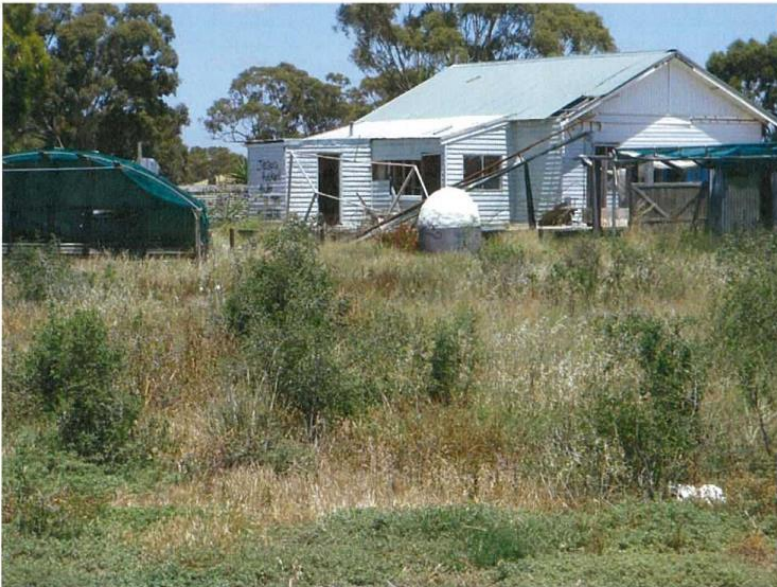
- 26) There are existing buildings towards the southern side of the Site, comprised of sheds and a timber framed, weatherboard house (Figure 4). The weatherboard house shows some evidence of ground movement, however generally appears to be intact.

Figure 4: Dilapidated weatherboard house, view towards south

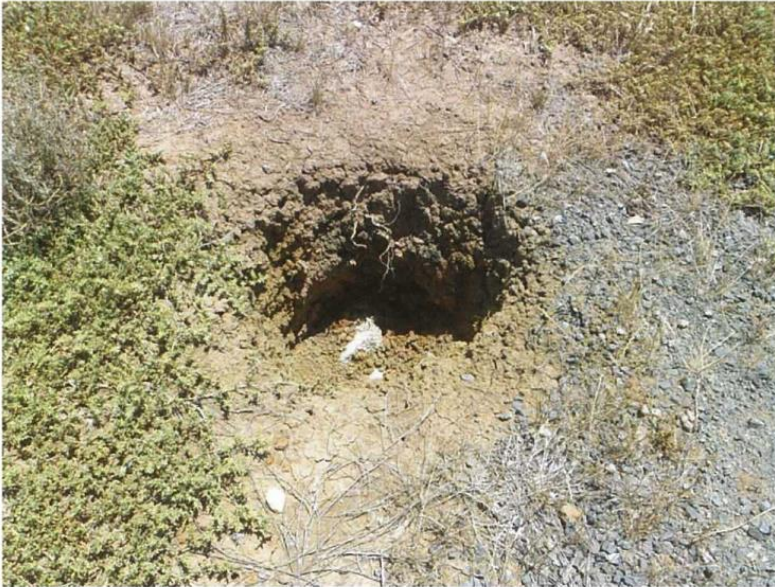
- 27) Based on a an observation of a series of holes of about 300 mm diameter, there appears to have been some recent excavation at the approximate location of the proposed mosque (Figure 5). Fill assumed to have been removed from the excavation appears to have been placed adjacent to these holes.

Figure 5: Circular excavation near location of proposed mosque

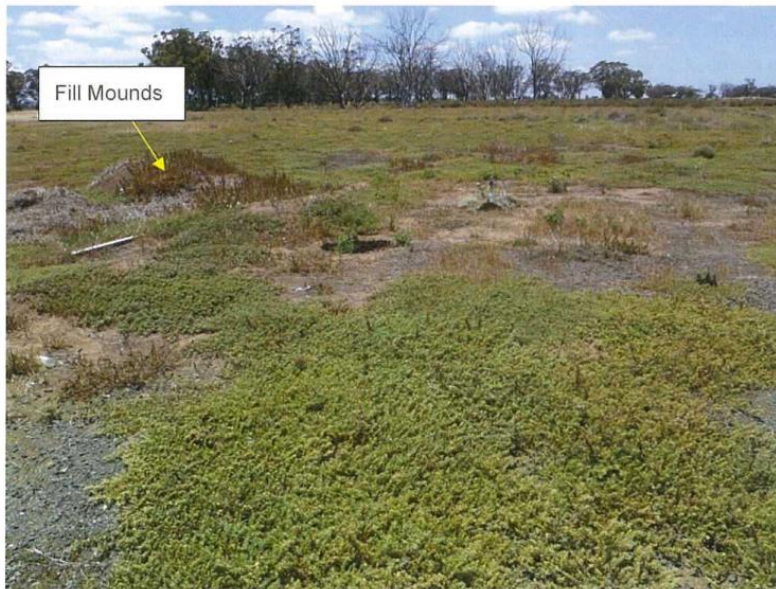
- 28) There are subtle gilgai features at the location of the proposed mosque (Figure 6). However, these features are not as pronounced as they are on other parts of the Site.

Figure 6: Approximate location of proposed mosque, view to east.

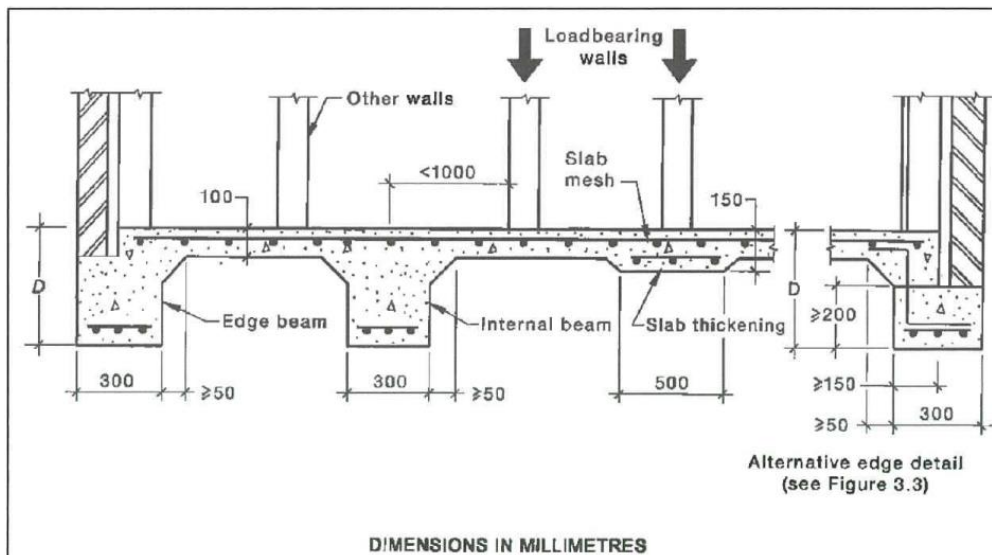
Figure 7: Example of a stiffened slab (Figure 3.1 from AS2870 (2011))¹¹

- 64) If appropriately designed, I consider that a stiffened slab could:
- Reduce movement of the structure such that the risk of damage to the structure in ULS is acceptable.
