SYNTHETIC TURF REPORT FOR THE CITY OF MELTON

# **SOCCKER FIELDS** **SPRINGSIDE & BROOKSIDE**

December 2018

**RE: Condition Report of synthetic turf soccer fields**

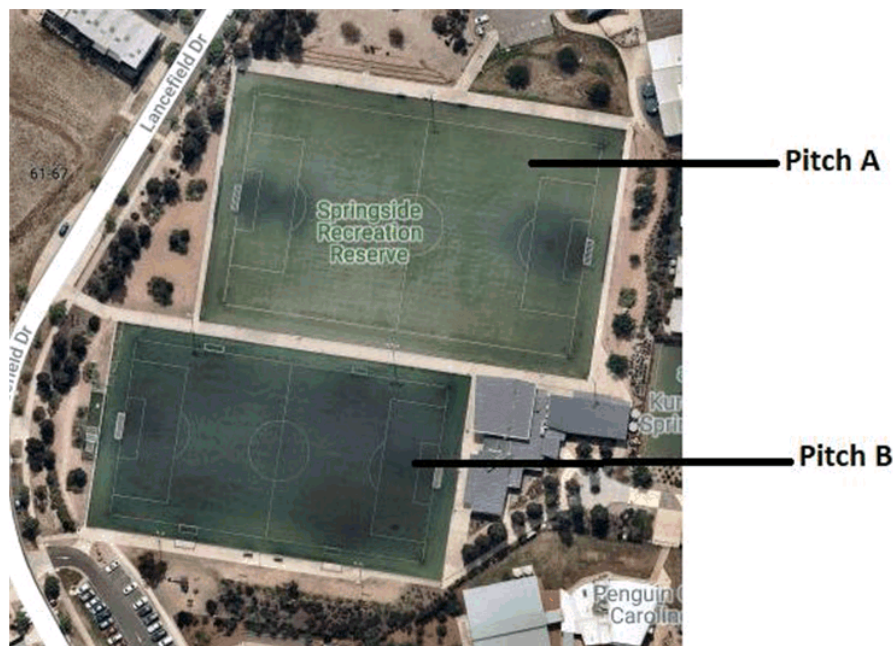
The two synthetic turf pitches were installed in 2008 using synthetic turf manufactured by APT, since the installation maintenance has been completed on a regular basis, there was a time approx. 3-4 years ago that the maintenance ceased until it was picked up again a couple of years later.

The pitches have a large amount of use from the surrounding schools, General Public and Soccer clubs, we are assuming that the facility would receive in excess of 70 + hours of use a week and is maintained on a quarterly basis.

The field is showing signs of wear and tear mainly in the heavy use spots such as goal boxes, penalty spots and corner spots, these are regularly topped up with crumbed rubber on each maintenance visit however over 10 years they are starting to wear out, the penalty spots have been replaced with new turf 3 times in the last few years.

The overall infill level of Pitch A is on the low side. This is due to the high level of use this pitch receives, even with the rubber topping up that we carried out over the years.

The overall infill level of pitch B is reasonable for use this pitch receive

The goal box at the both ends is in poor condition. We recommend completing a full replacement in the 6-yard box on both fields, as these will deteriorate very quickly due to the heavy use they receive.

SPRINGSIDE PITCH A: The seams on this pitch are in good condition, considering the age and high level of usage this pitch receives it is good to see.

SPRINGSIDE PITCH B: The seams on this pitch are in good condition, considering the age and high level of usage this pitch receives it is good to see.

- Increase Synthetic Turf maintenance from 4 times per year to monthly – this will ensure the field will last another 2 – 3 years approx.
- Replace the 6-yard boxes on both fields with new 40mm sand rubber filled synthetic turf to improve playability In the high wear areas
- Replace the penalty spots on each field x4 in total
- There would be approx. 2 years left of life in these fields if the above was adapted.

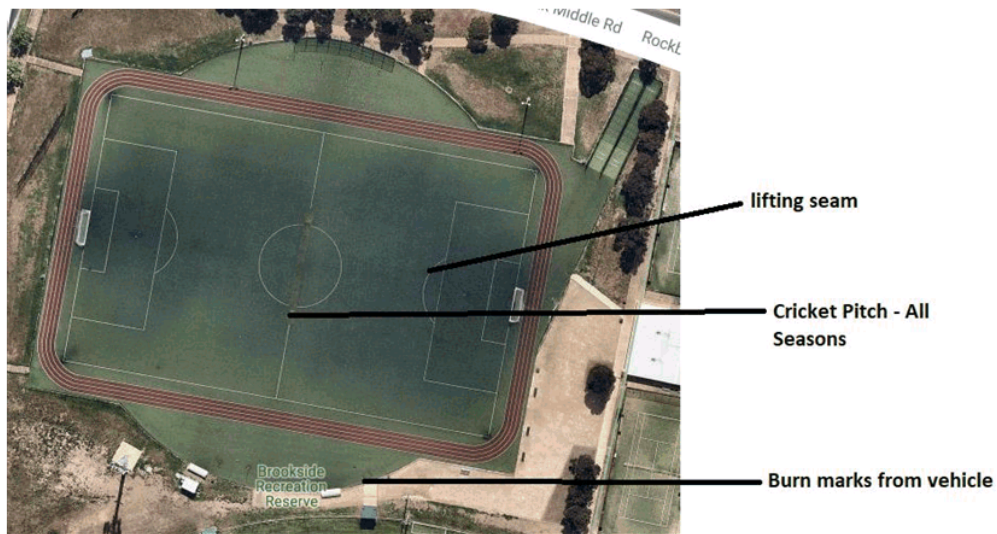
The synthetic turf pitch at Brookside was installed in 2008 using synthetic turf manufactured by APT, since the installation maintenance has been completed on a regular basis, there was a time approx. 3-4 years ago that the maintenance ceased until it was picked up again a couple of years later.

The pitch has a large amount of use from the surrounding schools, General Public and Soccer clubs, we are assuming that the facility would receive in excess of 70 + hours of use a week and is maintained on a quarterly basis.

The field is showing signs of wear and tear mainly in the heavy use spots such as goal boxes, penalty spots and corner spots, these are regularly topped up with crumbed rubber on each maintenance visit however over 8 years they are starting to wear out, the penalty spots have been replaced with new turf 3 times in the last few years.

The centre cricket wicket is laid on a concrete slab with a rubber matting underneath the synthetic turf which is becoming an issue on the edges. The all seasons pitch was installed separately to the main field in 2010.

The overall infill level is on the low side. This is due to the high level of use this pitch receives, even with the rubber topping up that we carried out over the years.

The goal box at the both ends is in poor condition. We recommend completing a full replacement in the 6-yard box on both fields, as these will deteriorate very quickly due to the heavy use they receive.

The seams on this pitch are in good condition, considering the age and high level of usage this pitch receives it is good to see. – there is an issue on the eastern end goal box where the seam seems to be breaking away that needs addressing before it becomes worse.

BROOKSIDE: The cricket wicket is in poor condition and we have done several repairs to the edge of the grass, trying to help extend the life of the wicket as well as reduce the chances of them becoming a tripping hazard.

- Increase Synthetic Turf maintenance from 4 times per year to monthly – this will ensure the field will last another 2 – 3 years approx.
- Replace the 6-yard boxes with new 40mm sand rubber filled synthetic turf to improve playability in the high wear areas
- Replace the penalty spots on each field x2 in total
- Replace the cricket pitch Cricket Victoria approved 9mm Supergrasse shield directly to the concrete slab.
- There would be approx. 2 years left of life in this fields if the above was adapted.
