Gilgai and reactive soil geohazards in the City of Melton

Including the Planning Application for a
Place of Worship at 171-197 Harkness Rd,
Harkness

Prepared by: Associate Professor Peter Dahlhaus, Principal Research Fellow

Prepared for: Melton City Council

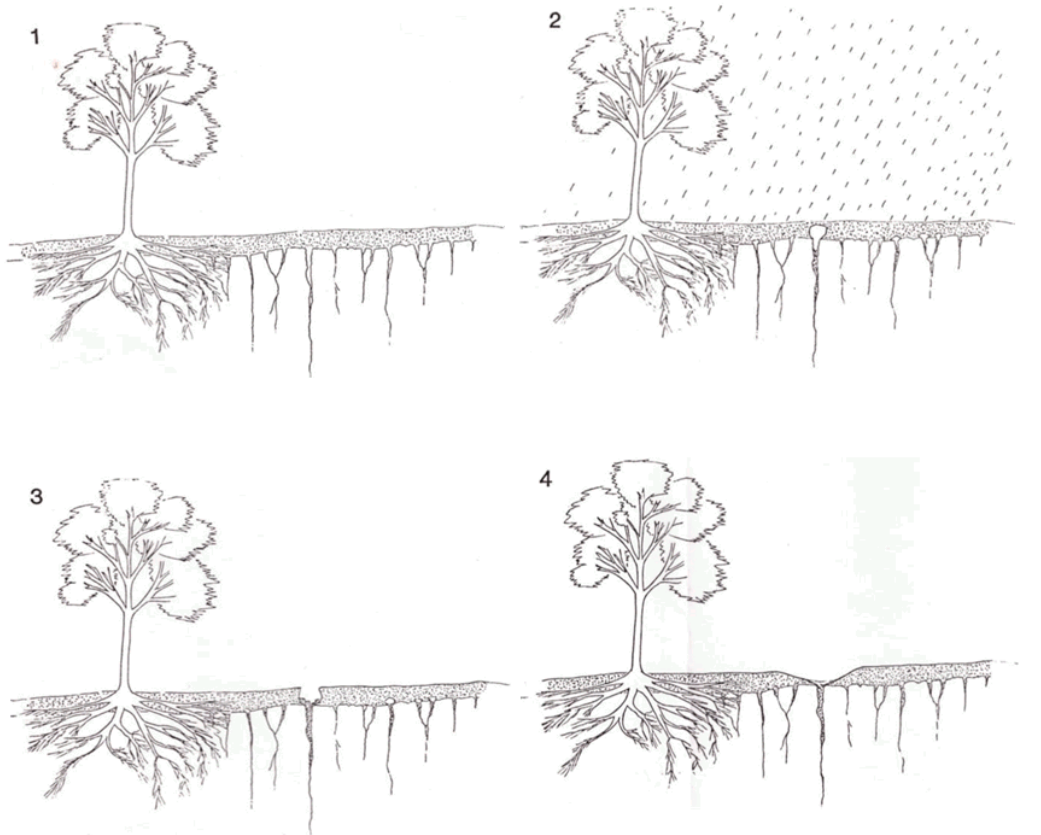
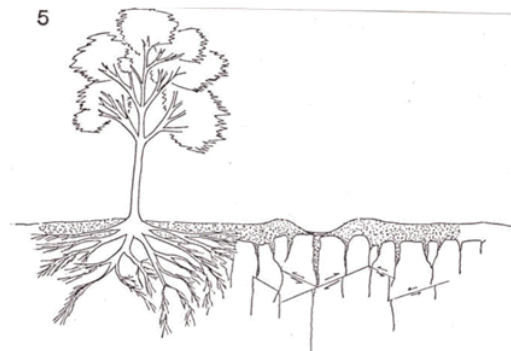
Figure 8. A proposed mechanism for the soil subsidence observed at Melton (Harkness).

In this area a relatively thin layer of sand and gravel overlies thick clay-rich subsoils and this profile provides a proposed mechanism for the subsidence (Figure 8). The conceptualisation fits with most observed features, especially the numerous fissures seen in all soil cores extracted from all bores drilled at the site. Fissuring was logged through the full depth of the profile - over nine metres in places - many fissures filled with sand with tree rootlets along the fissures, and many with polished surfaces (termed slickensides) caused by movement (shear failure of the soil).

1. The deep, clay-rich, highly reactive subsoil is desiccated by the vegetation, causing deep shrinkage cracks that are obscured by the overlying (unreactive) silty, sandy topsoils.
2. The topsoil falls into the soil cracks, assisted by rainfall infiltration. The weakly cemented top soil arches across the subsoil crack, creating a void.
3. The topsoil collapses forming a 'sinkhole'.
4. The sides of the sinkhole are eroded into a saucer-shaped depression.
5. The subsequent swelling of the subsoil creates shear stresses, slickensides and fissures to buckle the surface into typical gilgai relief.

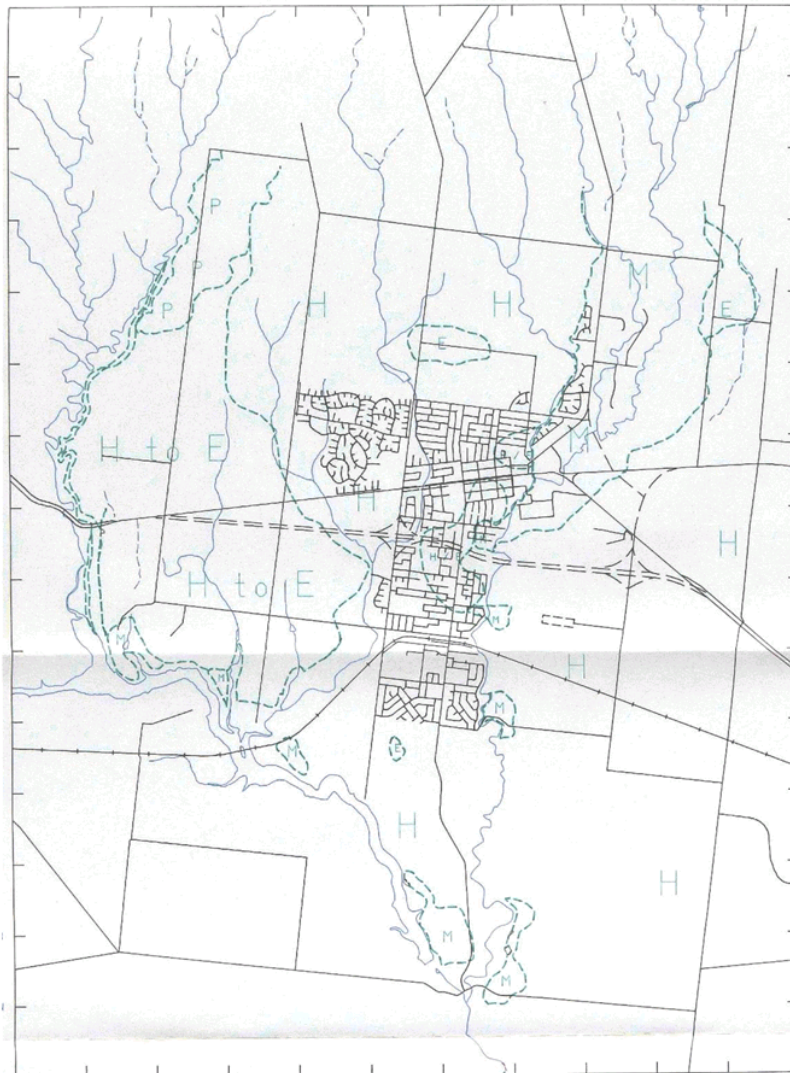
Figure 9. Site classification based on AS2870-1986. (from Dahlhaus, 1986c)

Almost all the Melton Development Area is rated as Highly Reactive sites (Class H), with some Extremely Reactive sites (Class E). Moderately Reactive sites (Class M) are mapped where thicker alluvial gravels overlie the basalt along Toolern Creek and at Exford. The north west corner where soil collapse occurs is rated as Problem sites (Class P).

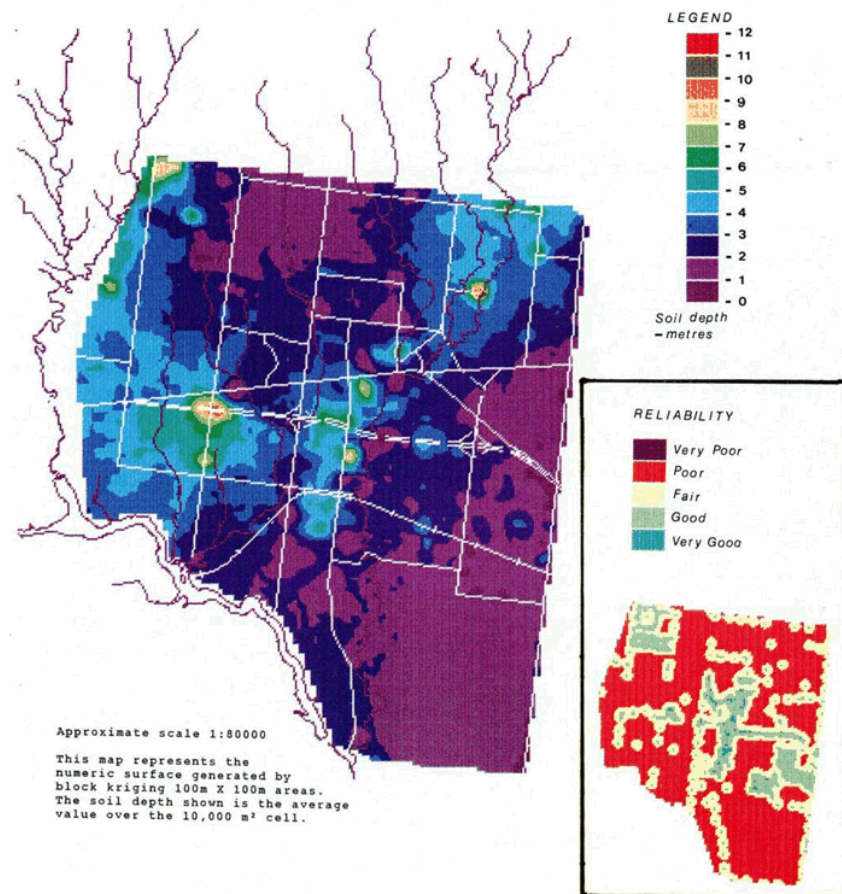
Figure 10. Soil thickness map (from Dahlhaus, 1986f)

Since shallow rock was considered an economic constraint to urban subdivision and the installation of services at Melton, statistical methods, known as kriging, was used to develop soil thickness maps (Figure 10). The soil thickness maps were also useful in assisting the site classification mapping, since the depth of soil is a determinant on how much heave can be expected at the surface.

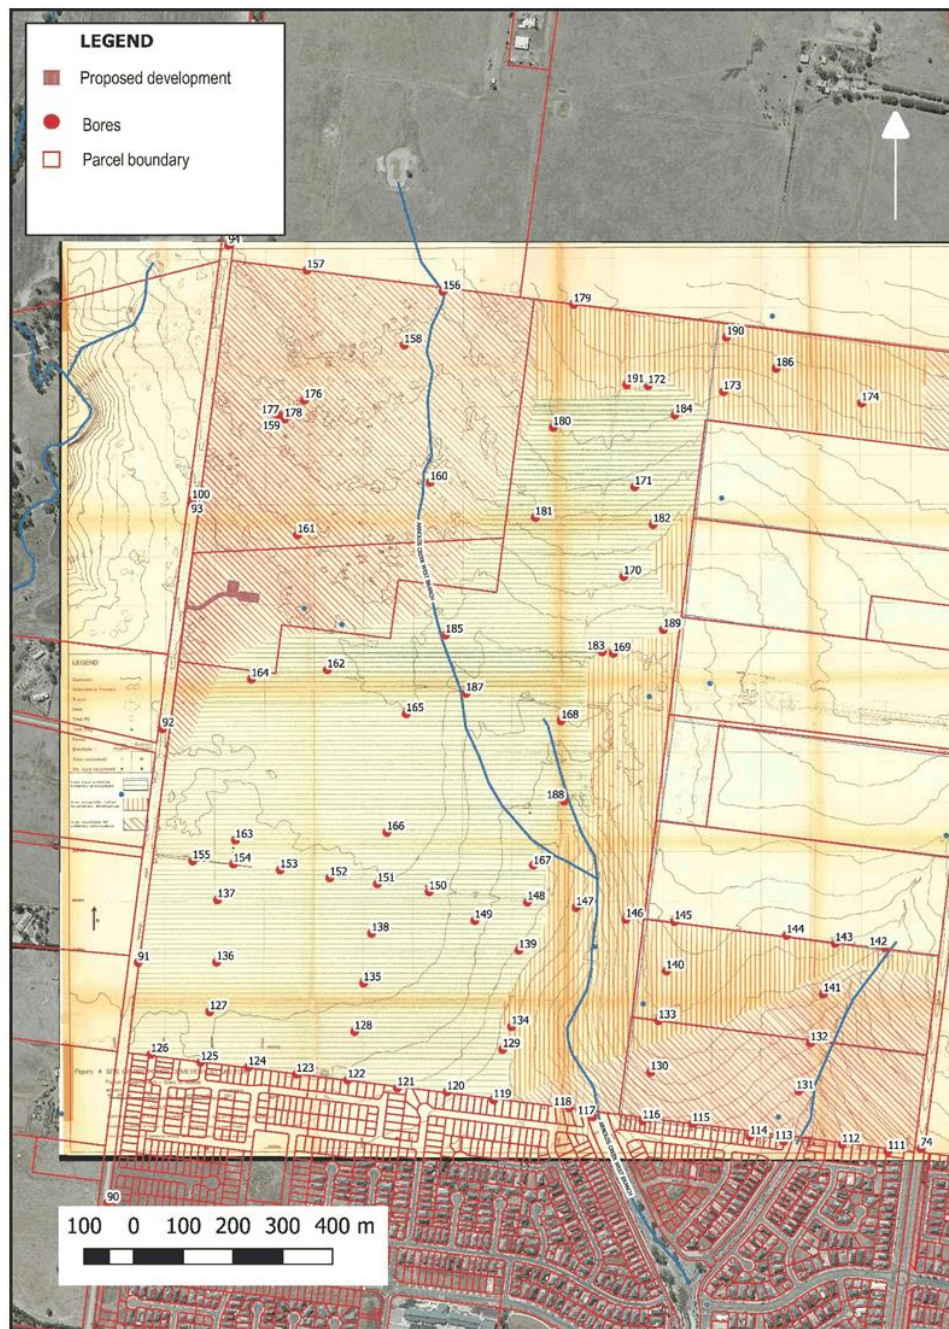
Figure 11. Mapped suitability for the proposed cemetery (1984).

The area was intensively investigated for both the Health Commission for the proposed Melton Regional Cemetery (1984), and the Urban Land Authority (1985) for potential subdivision. The cemetery investigation ruled out the area as suitable for cemetery development (Figure 11) due to the unpredictable occurrence of soil collapse, topographic development of mounds and hollows, and the number of trees (Dahlhaus, 1984). The subsequent investigation for the potential subdivision noted the following challenging constraints (Dahlhaus, 1985):

Red is unsuitable, orange is marginal, and green is suitable. Overlain with the current cadastre and proposed development

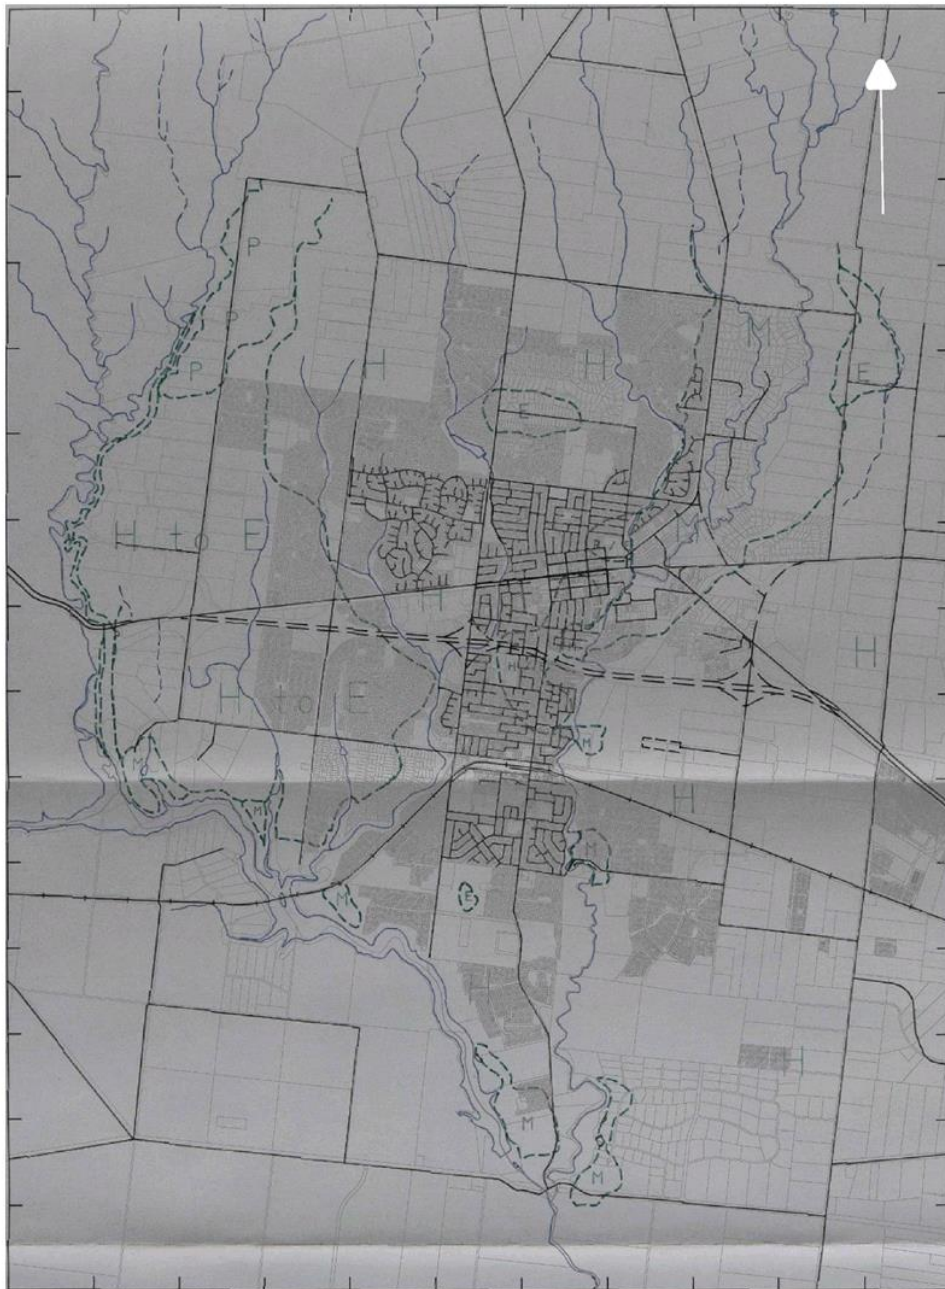
Figure 15. The original 1986 Site Classification mapping overlain with the current Melton cadastre (in grey).

The thicker highly to extremely reactive soil in Melton West exhibits the most obvious three-dimensional movement over distances of many metres, as observed by the subtle gilgai development before urban development (Figure 4; Dahlhaus, 1988; SCA, 1978). Therefore, these expansive soils constitute a whole of landscape geohazard, like salinity or floods. The current development footprint over the area (Figure 15) has extended suburban development over about half of the area with the thicker, highly to extremely reactive soils (Figure 15). This suburban development is underlain by an uneven blanket of residual soil, which is interpolated to be two to five metres thick with heterogeneous and anisotropic properties due to the way it has evolved through geologic time. This blanket of reactive soil continues to respond (in three dimensions) to the incremental urban development and the temporal climatic and anthropogenic moisture variations. It is perhaps analogous to a gel-filled quilt of uneven thickness and consistency, slowly responding to changes brought about by urban development at the surface. Buildings, pavements, drainage, landscaping, trees, and utility trenches all change the moisture distribution of the regolith. Areas that were once open to rainfall percolation are now covered by impervious surfaces, and other areas, such as those adjacent to lakes, or parks and gardens are now receiving more water percolation than previously. This slow response of the regolith to the altered soil hydrology extends beyond the boundaries of any individual property. It is a whole of landscape feature.

In other words, the landscape and hydrological changes on one property may, in time, result in a deep-seated expansive soil response on a neighbouring property, especially where close urban development has occurred that has changed the pre-existing soil hydrology regime.

This is particularly a problem where trees and garden irrigation are in close proximity to the allotment boundaries and includes street trees and nature strips. The Eucalyptus trees planted along the roadsides throughout the West Melton estates (e.g. Panorama Drive, Merrystowe Way, Arjun Avenue, etc.), have the potential, in my opinion, to cause considerable damage to infrastructure in the future. Eucalyptus trees are a known problem in areas of highly expansive soils (e.g. AS2870, 2011; Cameron, 2001; Jones & Jefferson, 2012).

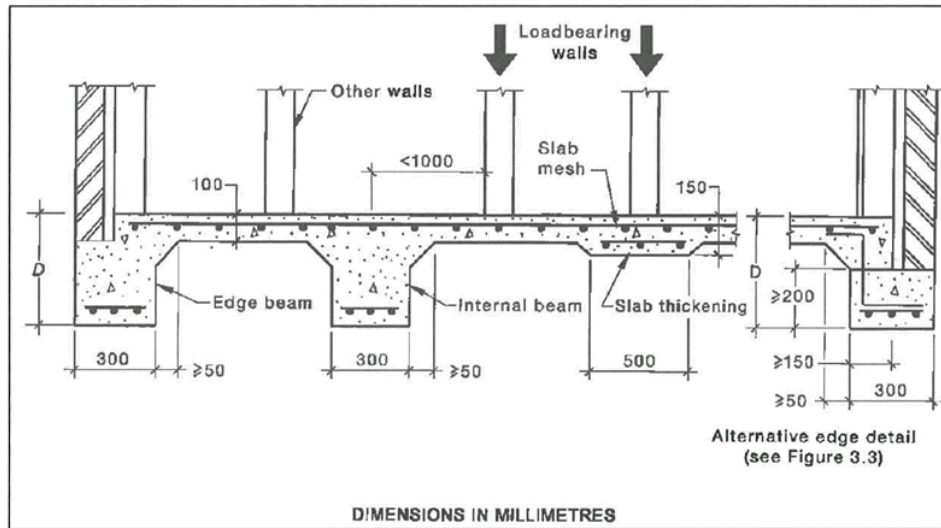
Figure 7: Example of a stiffened slab (Figure 3.1 from AS2870 (2011))¹¹

- 63) An example of a stiffened slab is presented in Figure 7.

- 64) If appropriately designed, I consider that a stiffened slab could:
- Reduce movement of the structure such that the risk of damage to the structure in ULS is acceptable.
