Gilgai and reactive soil geohazards in the City of Melton

Including the Planning Application for a
Place of Worship at 171-197 Harkness Rd,
Harkness

Prepared by: Associate Professor Peter Dahlhaus, Principal Research Fellow
Prepared for: Melton City Council

Date: 31/08/2018

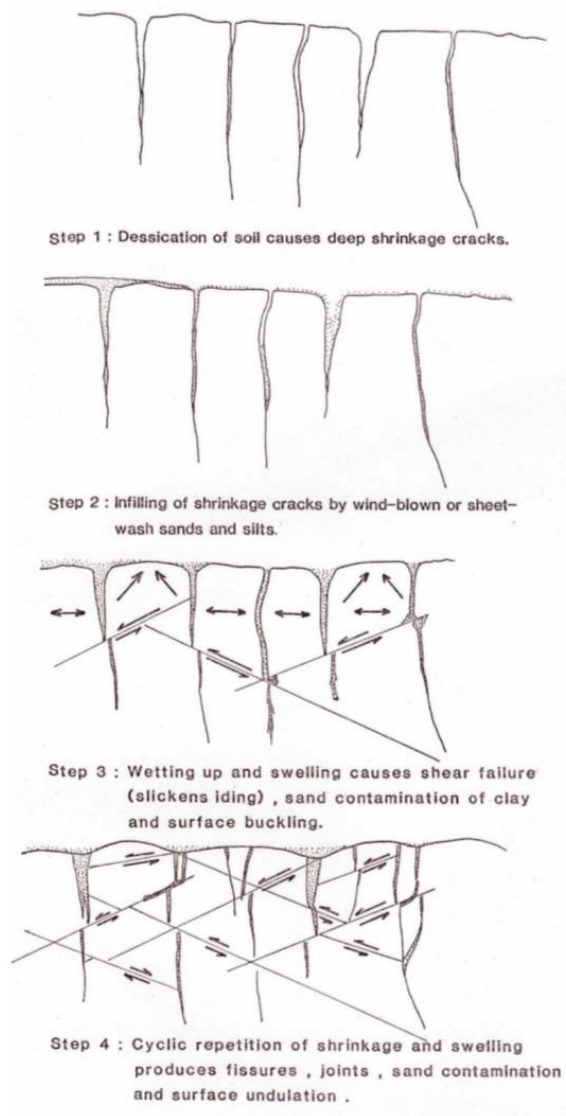
Figure 3. The process that leads to the formation of gilgai.

Gilgai is the term given to landforms (or micro-relief) that appear as subtle mounds and depressions in the landscape. The term is taken from an Australian Aboriginal word for waterhole, since the depressions sometimes contained pools of water. Recognised around the world, gilgai form in reactive soils through the repeated cycles of shrinking and swelling (Figure 3).

The Certain likelihood of the geohazard presence, is confirmed by the observations, soil thickness and tests, and observed features in the soil cores that confirm that the gilgai process (Figure 3) is ubiquitous and deep-seated across the neighbouring sites. Shrinkage cracks appearing in summer can extend from the surface to the entire depth of the soil profile, in some cases up to eight metres, as described in detail in the previous investigation reports. Rainfall runoff, irrigation water and wastewater infiltration can quickly penetrate down the cracks and sand-filled fissures, both laterally and vertically and the resulting swelling of the soil at depth may also occur some metres away from the point of infiltration.

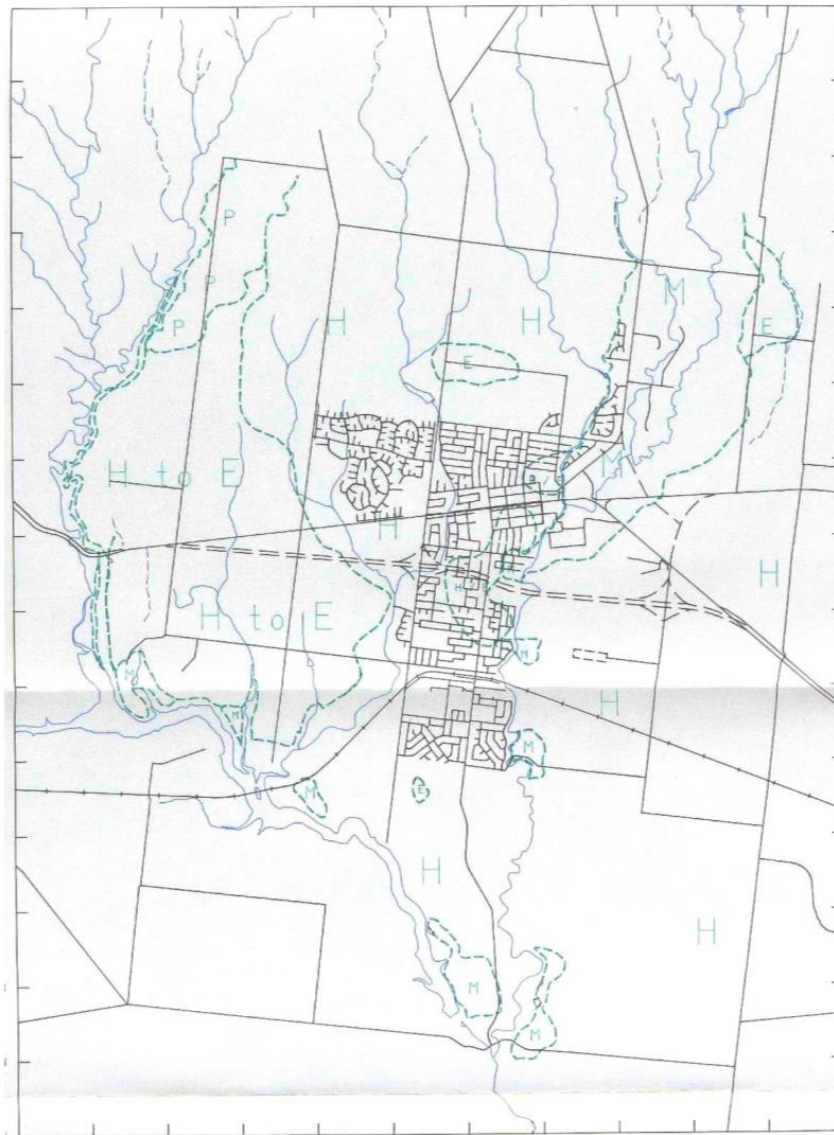
Figure 9. Site classification based on AS2870-1986. (from Dahlhaus, 1986c)

Almost all the Melton Development Area is rated as Highly Reactive sites (Class H), with some Extremely Reactive sites (Class E). Moderately Reactive sites (Class M) are mapped where thicker alluvial gravels overlie the basalt along Toolern Creek and at Exford. The north west corner where soil collapse occurs is rated as Problem sites (Class P).

As described in Section 2.2, the principal geohazard at Melton is the Highly Reactive to Extremely Reactive soil (Figure 9), which can be identified at the surface by the development of gilgai microrelief, where the soils are thicker (Figure 10). In the Harkness area, where the gilgai processes are present under the blanket of sandier topsoil, soil collapse and subsidence can be seen.

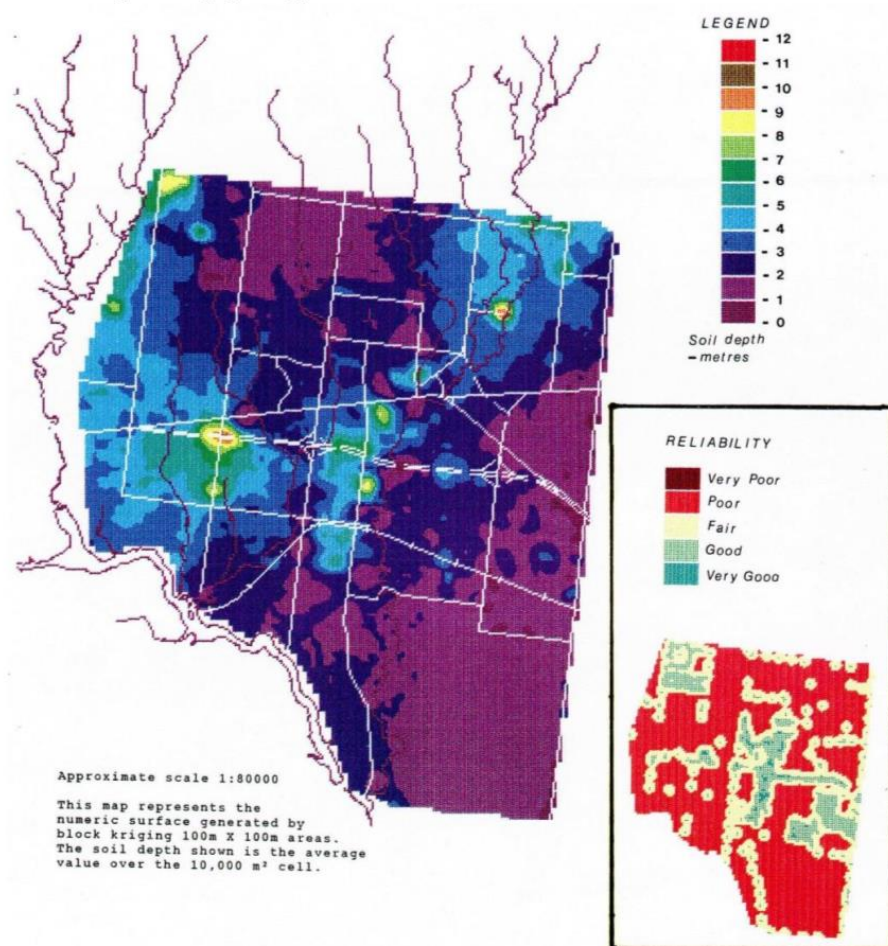
Figure 10. Soil thickness map (from Dahlhaus, 1986f)

Since shallow rock was considered an economic constraint to urban subdivision and the installation of services at Melton, statistical methods, known as kriging, was used to develop soil thickness maps (Figure 10). The soil thickness maps were also useful in assisting the site classification mapping, since the depth of soil is a determinant on how much heave can be expected at the surface.

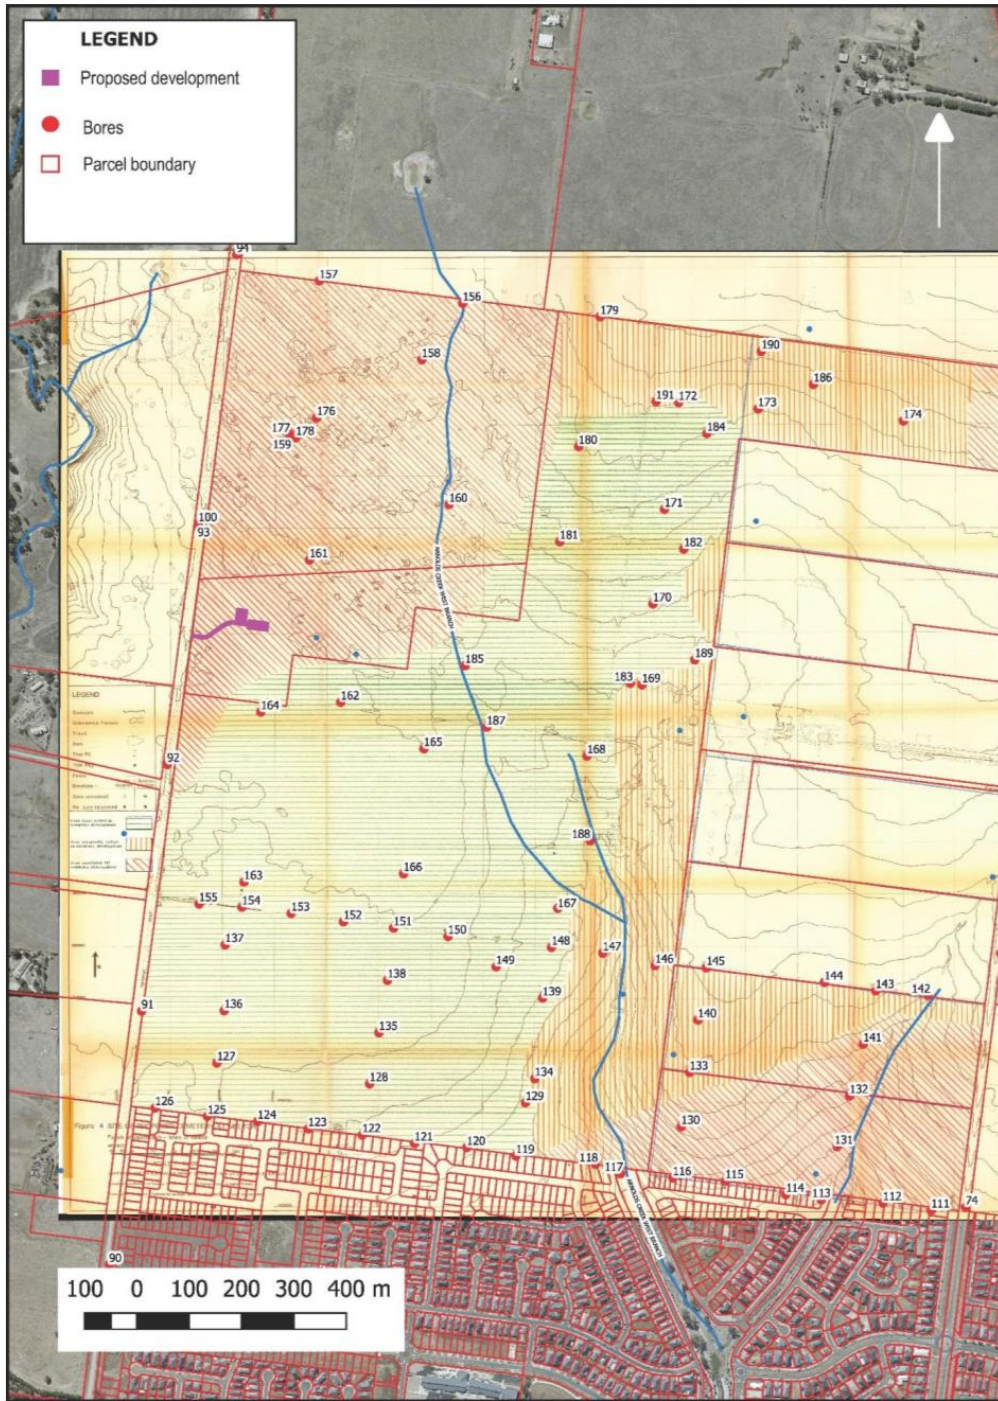
Figure 11. Mapped suitability for the proposed cemetery (1984).

The area was intensively investigated for both the Health Commission for the proposed Melton Regional Cemetery (1984), and the Urban Land Authority (1985) for potential subdivision. The cemetery investigation ruled out the area as suitable for cemetery development (Figure 11) due to the unpredictable occurrence of soil collapse, topographic development of mounds and hollows, and the number of trees (Dahlhaus, 1984). The subsequent investigation for the potential subdivision noted the following challenging constraints (Dahlhaus, 1985):

Red is unsuitable, orange is marginal, and green is suitable. Overlain with the current cadastre and proposed development

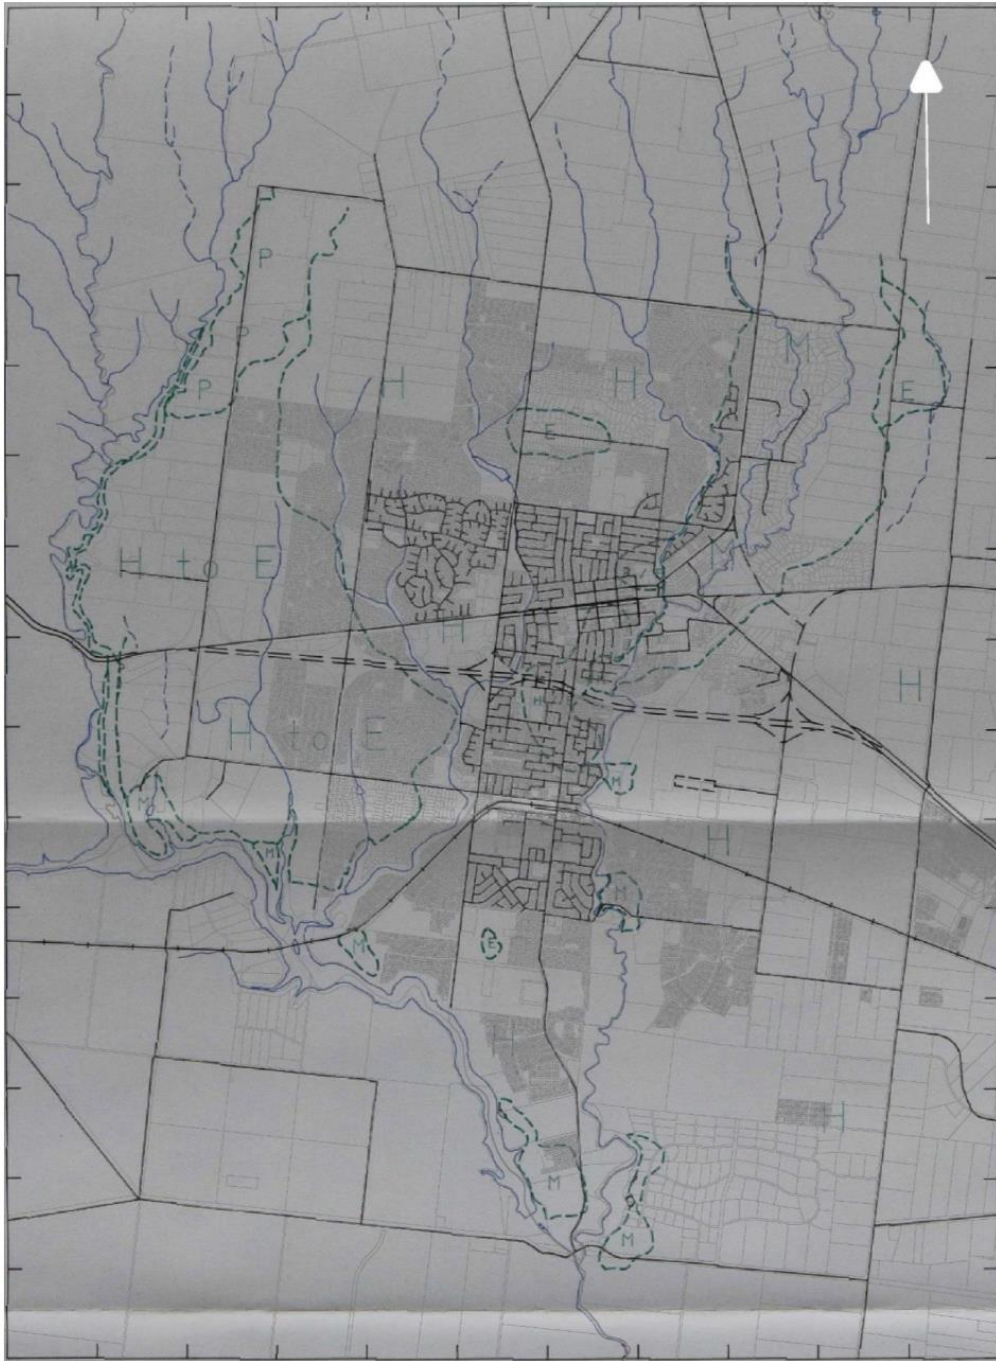
Figure 15. The original 1986 Site Classification mapping overlain with the current Melton cadastre (in grey).
